ENVIRONMENTAL AUTHORISATION
AND ENVIRONMENTAL
MANAGEMENT PROGRAMME
COMPLIANCE AUDIT

# ASSMANG BLACK ROCK MINE OPERATIONS, HOTAZEL, NORTHERN CAPE

Audit Report Date: 04 December 2019

EScience Ref: BRMA2019

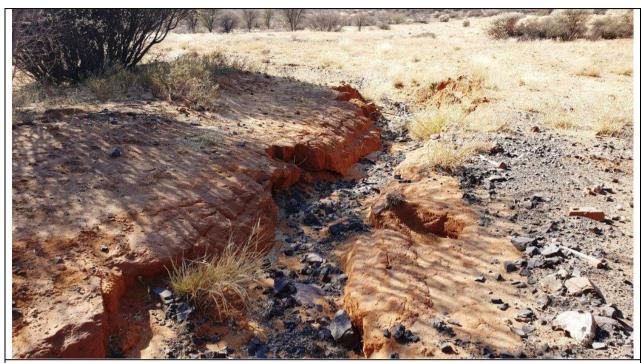
Figure 6.1: Erosion in rehabilitated area on Gamagara riverbank 1

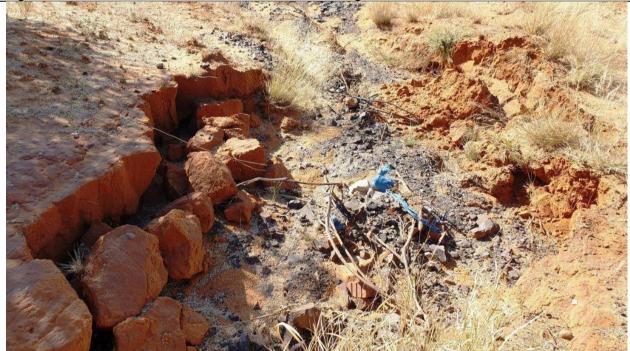
Figure 6.2: Erosion in rehabilitated area on Gamagara riverbank 2

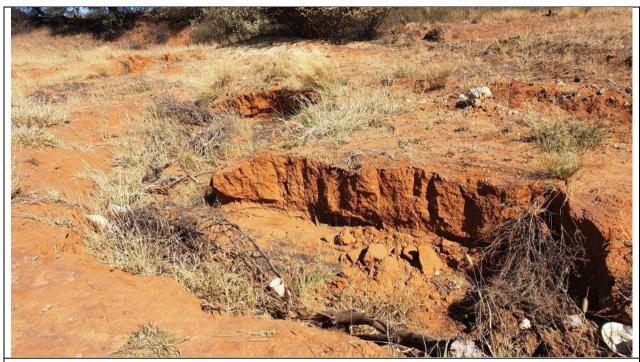
Figure 6.3: Erosion in rehabilitated area on Gamagara riverbank 3

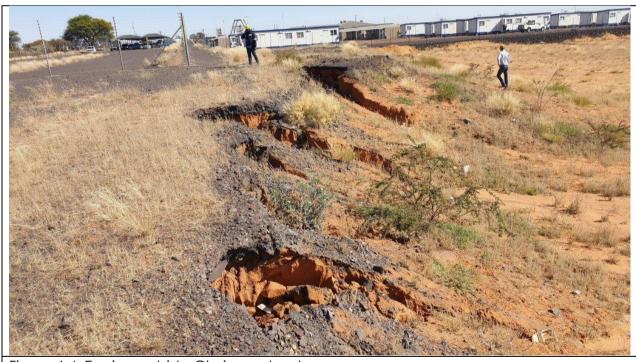
Figure 6.4: Erosion outside Gloria contractor camp

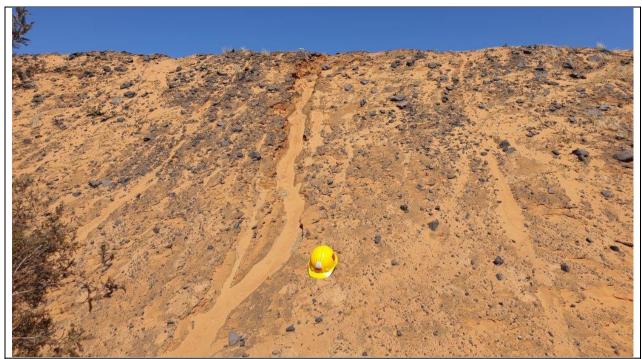
Figure 6.5: Erosion outside at Nchwaning 2 subsoil stockpiles from construction of the new TSF.

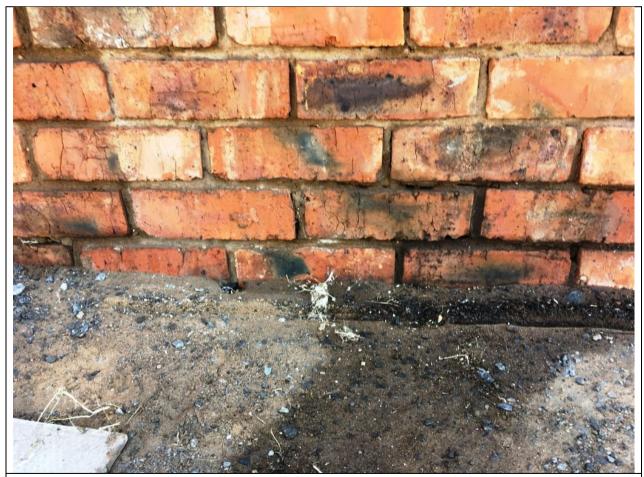
Figure 6.6: Leak emanating from the bund at Black Rock Hazardous Waste Transfer Station

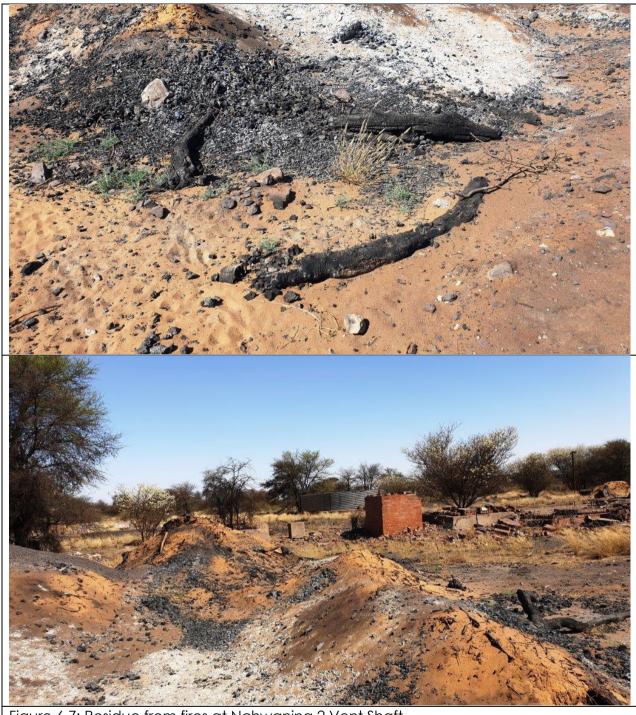
Figure 6.7: Residue from fires at Nchwaning 2 Vent Shaft

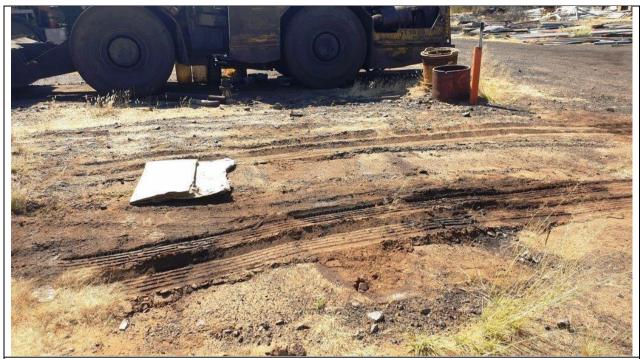
Figure 6.8: Contaminate Soil at Black Rock salvage yard

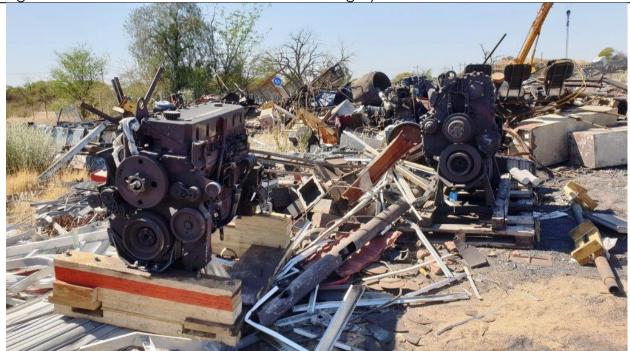
Figure 6.9: Scrapped Engines at Black Rock salvage yard not stored in bunds

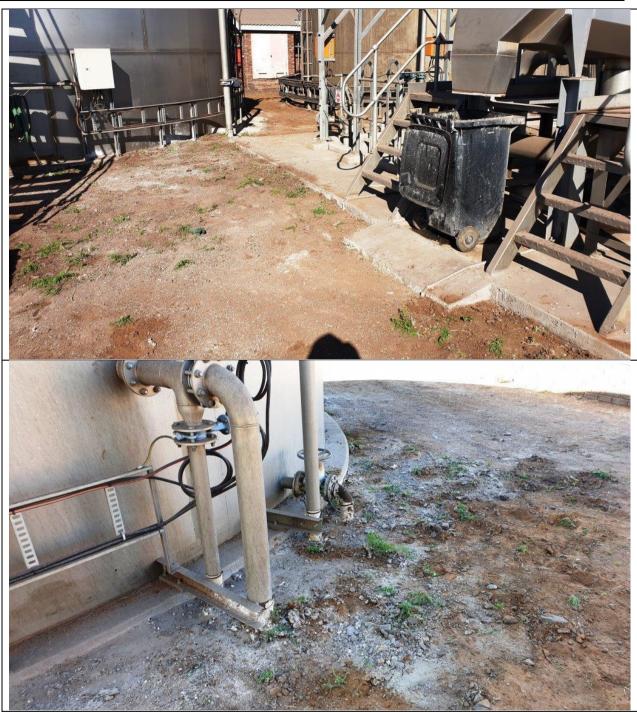
Figure 6.10: Overflows from at Gloria Sewage Treatment Plant

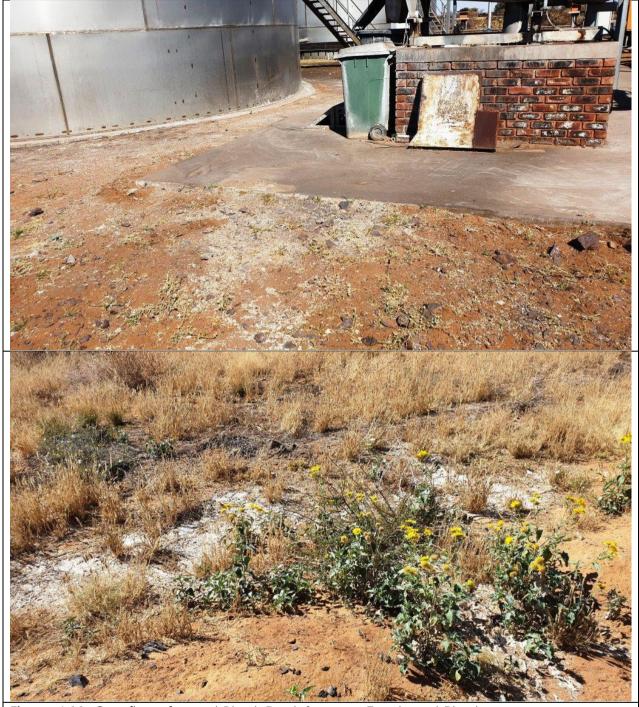
Figure 6.11: Overflows from at Black Rock Sewage Treatment Plant

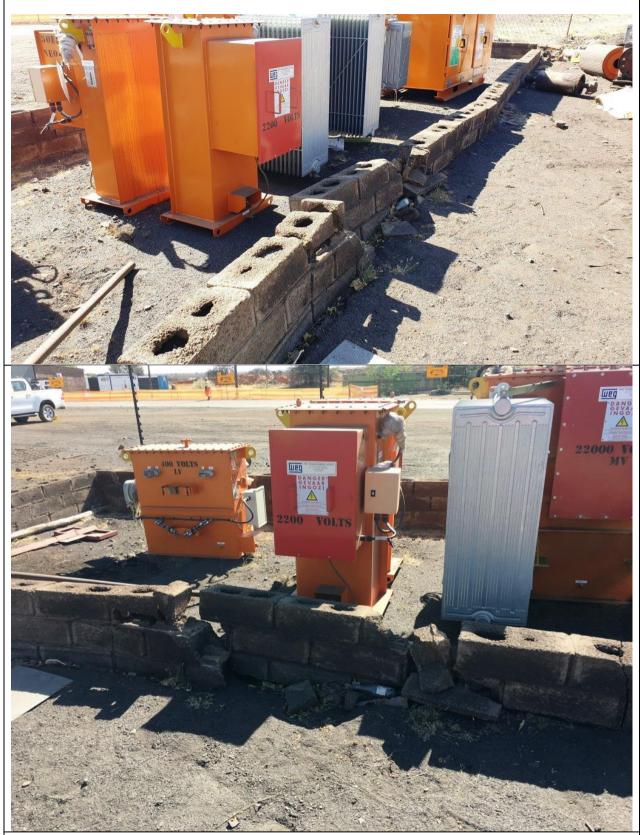
Figure 6.12: Example of defective bunds at Gloria Workshop

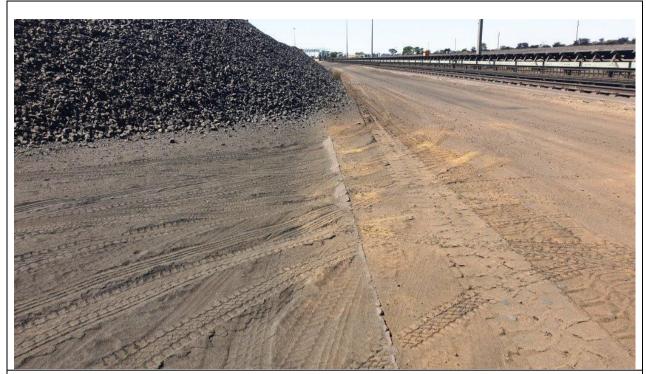
Figure 6.14: Stacker-reclaimer stormwater drains blocked.

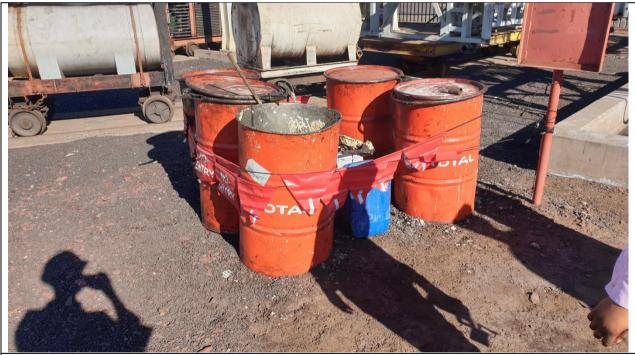
Figure 6.15: Nchwaning 3 Emulsion waste stored outside of bunded area.

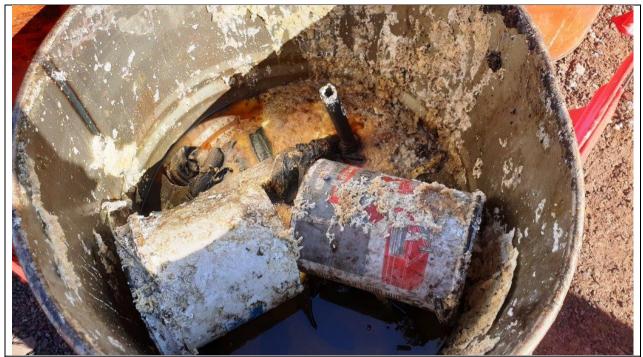
Figure 6.16: Nchwaning 3 Emulsion waste stored outside of bunded area.
