KHUMANI PASTE DISPOSAL FACILITY

INDEPENDENT TAILINGS REVIEW REPORT No 3

December 2022

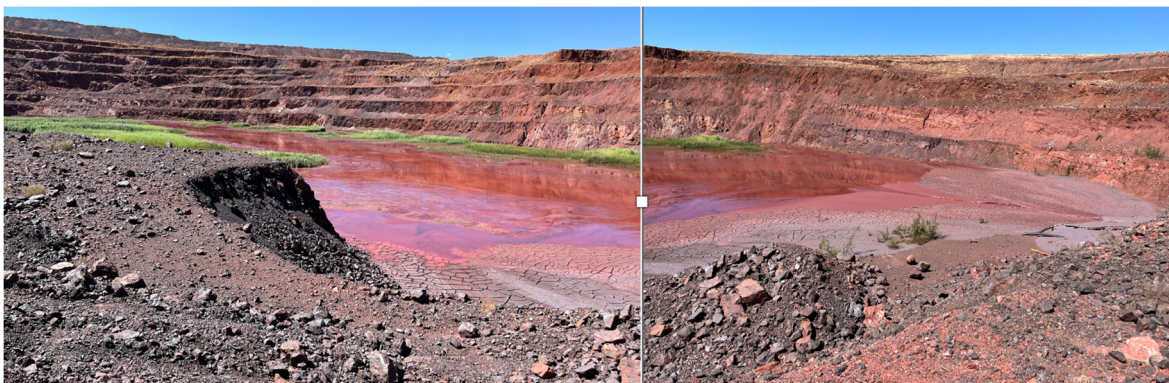
Water recovery from the active compartments, and specifically from Compartment 3B, does not appear to be optimal as beach formation is relatively flat, resulting in pools which are not consistently centered around the barge pump inlets. The following measures are proposed by the EoR and the Operating Contractor:

Photo 1: Deposition in Compartment 3B

- Introduction of Turret intake devices which will allow the intake of water at shallow depth;
- Experimenting with spray-bar deposition in Compartment 3B to improve beach formation.

The ITRB supports the proposed measures.

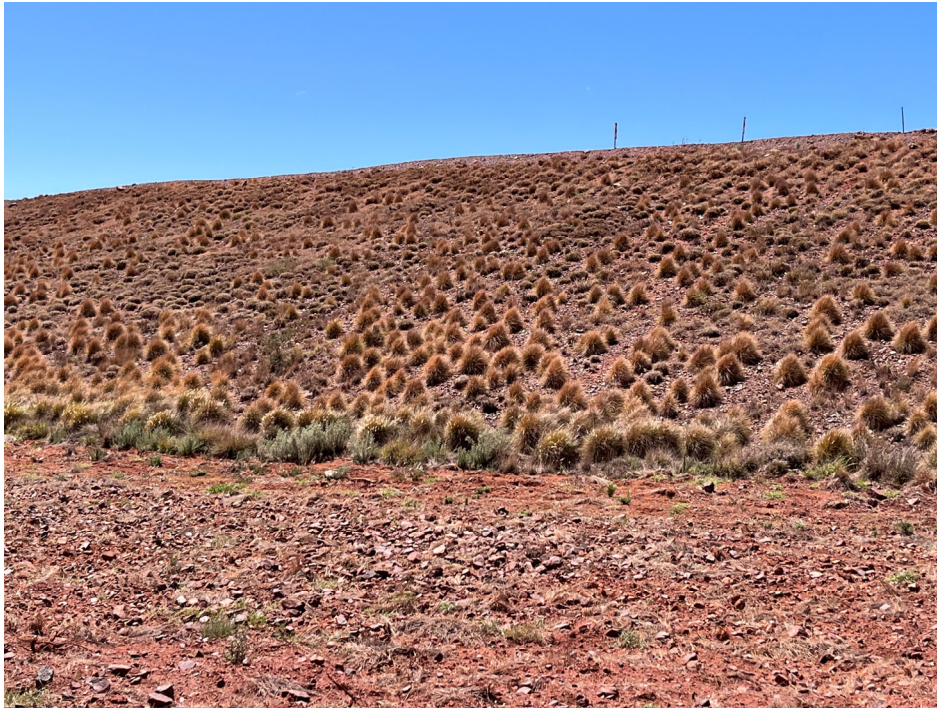
It was noted that vegetation has established on the waste rock starter wall and no erosion is evident. It is understood that vegetation trials are planned for the rehabilitation of the paste side-slopes. The trials will include a section with topsoil and a section in which the vegetation will be established directly into the paste.

Photo 2: Vegetation cover on waste rock starter wall

The ITRB recommends that consideration be given to mixing in waste rock into the topsoil or paste to provide a more erosion resistant surface, as it will be difficult to achieve a dense vegetation cover in such an arid climate area.

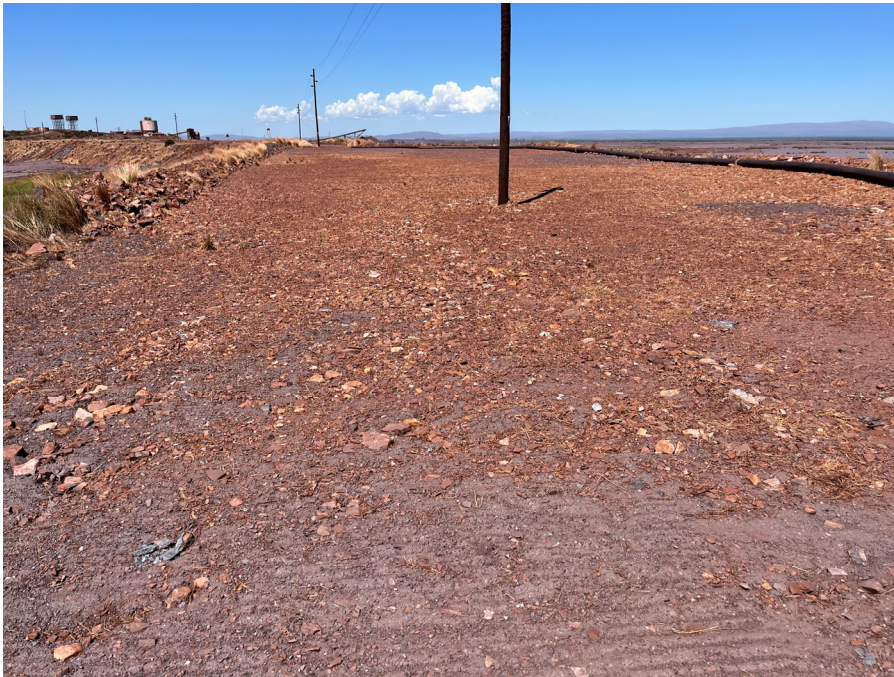
The sinkhole that formed in the south-east corner of Compartment 1, adjacent to Compartment 3A, was backfilled with gravelly material. No signs of subsidence of the backfill was noted and it was also noted that the basin of Compartment 1 was now covered with a layer of paste.

Photo 3: Backfilled sinkhole

The ITRB recommends that the possibility and consequence of reactivation of the sinkhole should be assessed with a view to reopening access to the division wall.
