# Beeshoek Iron Ore Mine: Deep Dolomite Study

Report Prepared for

**Assmang Beeshoek Iron Ore Mine**

Report Number 550354

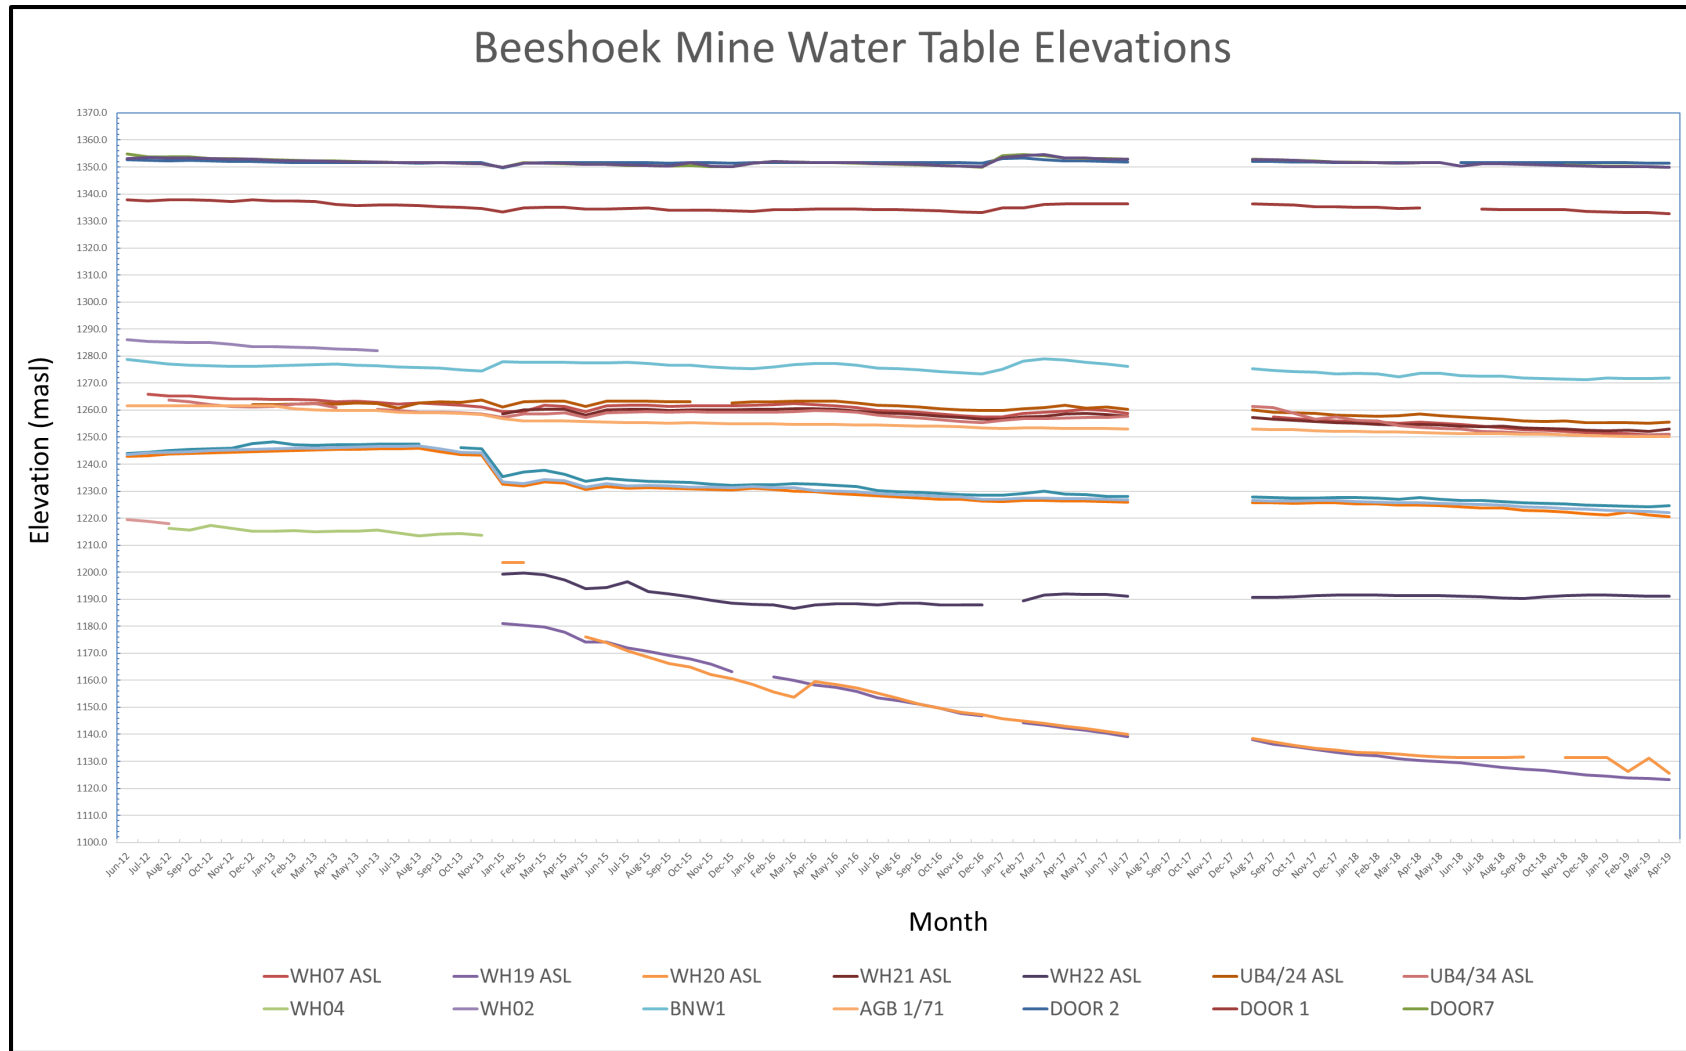
**BEESHOEK DEEP DOLOMITE STUDY**  
Beeshoek Mine Water Table Elevations

**Figure 5-1 Water table monitoring records from June 2012 to April 2019 at Beeshoek Mine**

A dataset of water level readings recorded by the Mine from June 2012 to April 2019 are presented in Figure 5.1. It can be seen from these levels that there is probable compartmentalisation of the

groundwater evidenced in the differing levels. It is also apparent that there is a steady lowering of the levels in each of the boreholes over the period due to both dewatering and groundwater use.

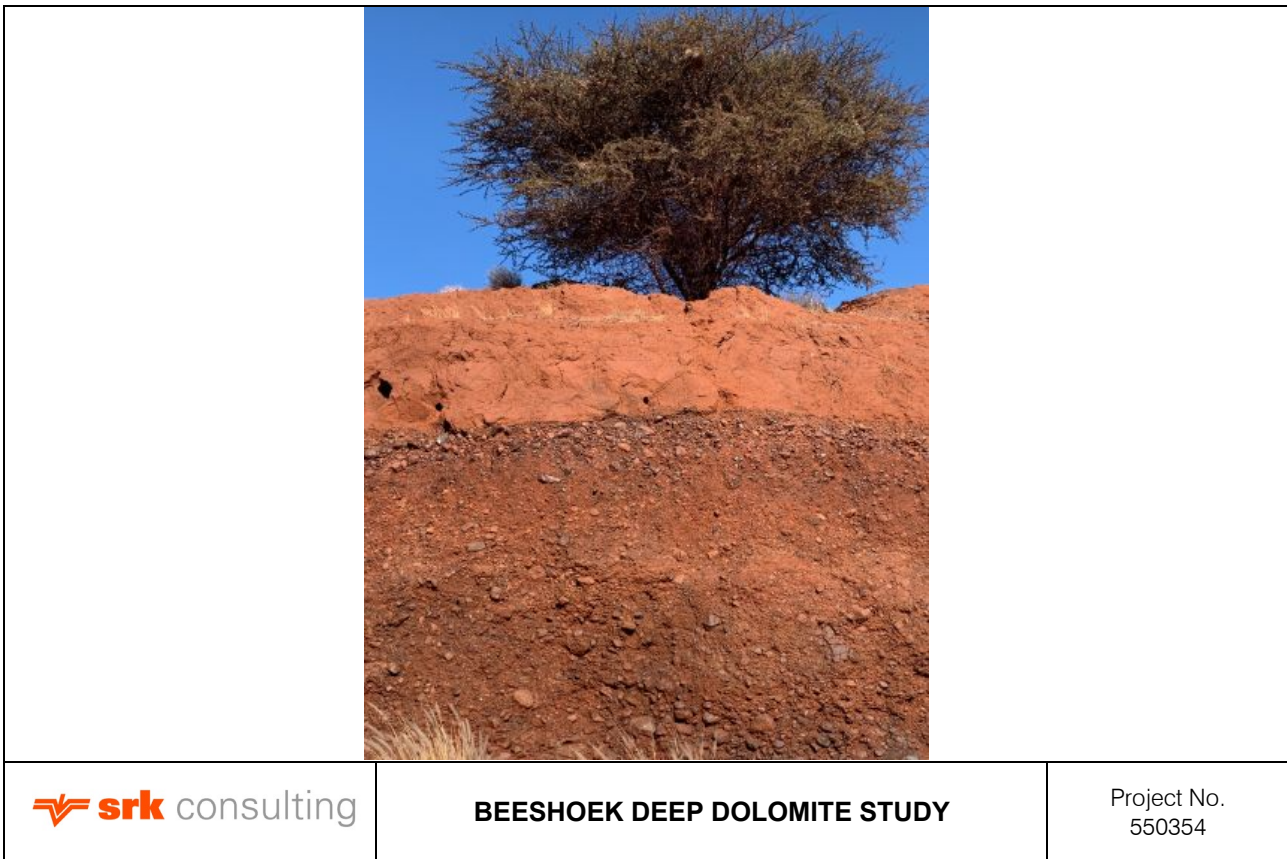
- Detrital mining area – in the lower lying areas detrital iron ore deposits are blanketed under an horizon of windblown Kalahari sand as illustrated in Figure 6.3.

**Figure 6-3 Aeolian Kalahari sand overlying detrital ore**

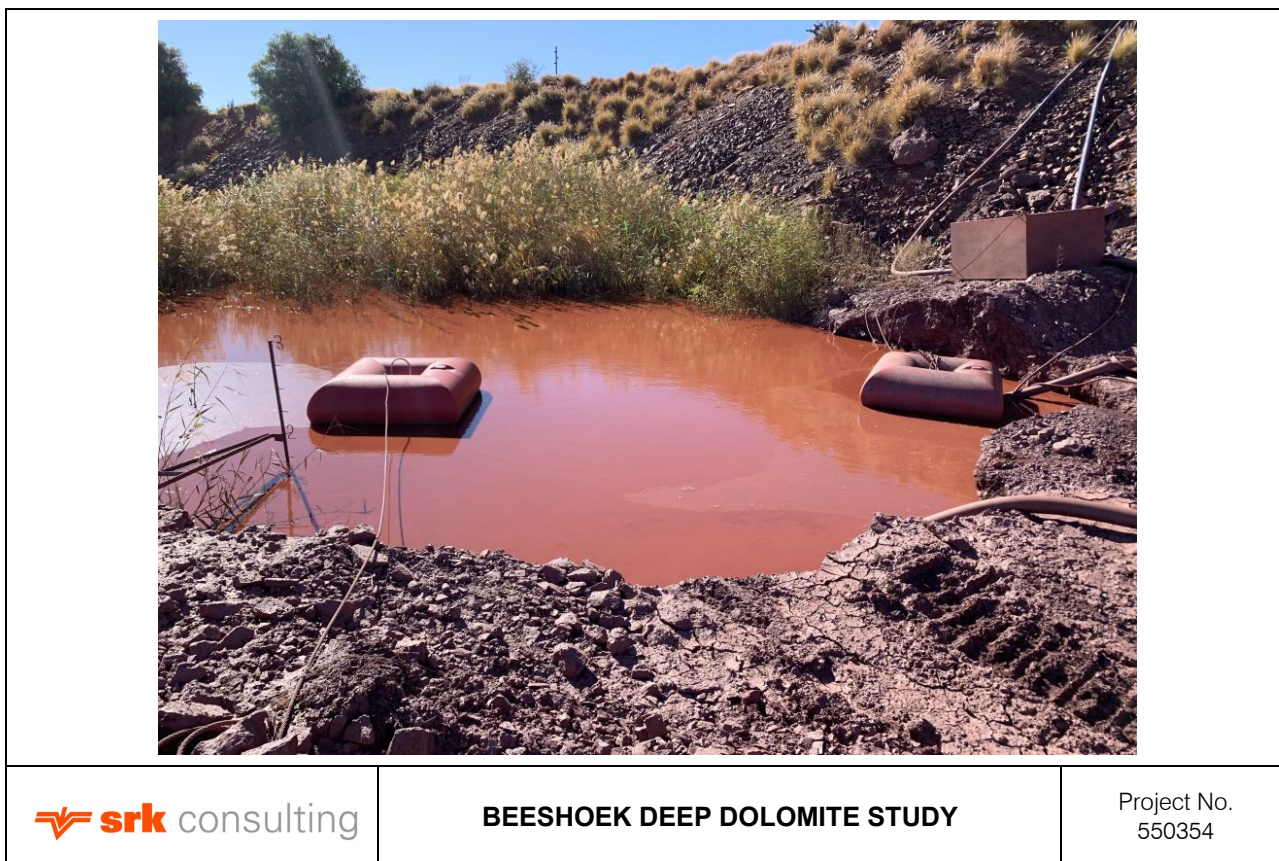
- Current Tailing Storage Facility in the north of the mine site – the TSF was inspected at the embankment wall against which the supernatant water has ponded on the northern side of the facility. Figure 6-5 shows the supernatant pond and barge from where the return water is pumped.

**Figure 6-5 Supernatant pond adjacent to TSF embankment**

A geotechnical investigation of the Beeshoek TSF embankment wall in a report titled "Beeshoek Iron Ore Mine Tailings Storage Facility - Geotechnical Investigation – SRK Report no. 547755" shows seepage to be occurring through the wall of the embankment. The CSIR InSAR deformation reports show two instances of subsidences within the basin of the TSF, which is underlain by dolomite at a shallow depth. The relationship between these observations and the risk to stability of the basin and embankments must be established by further investigation.

In mining of the Manganore Formation, the presence of cavities at the base of the Wolhaarkop Formation can be identified by targeted gravity surveys in future operational areas and drilling in advance of mining operations. Risks associated with the TSF from seepage through embankments and seepage through the basin need to be better understood. Investigation by gravity surveying and targeted drilling need to be explored to understand and quantify the risks. Wet services, such as water supply and slurry pipelines delivering waste to the TSF and stormwater accumulation and ponding,
