MINE EXPANSION AT ASSMANG
BLACK ROCK MINE OPERATIONS,
HOTAZEL, NORTHERN CAPE

**NCHWANING II AND III
CONTRACTOR AND CONSTRUCTION
PHASE AUDITS**

***Independent Audit Report: 2021
Quarter 1***

ENVIRONMENTAL COMPLIANCE AUDIT REPORT

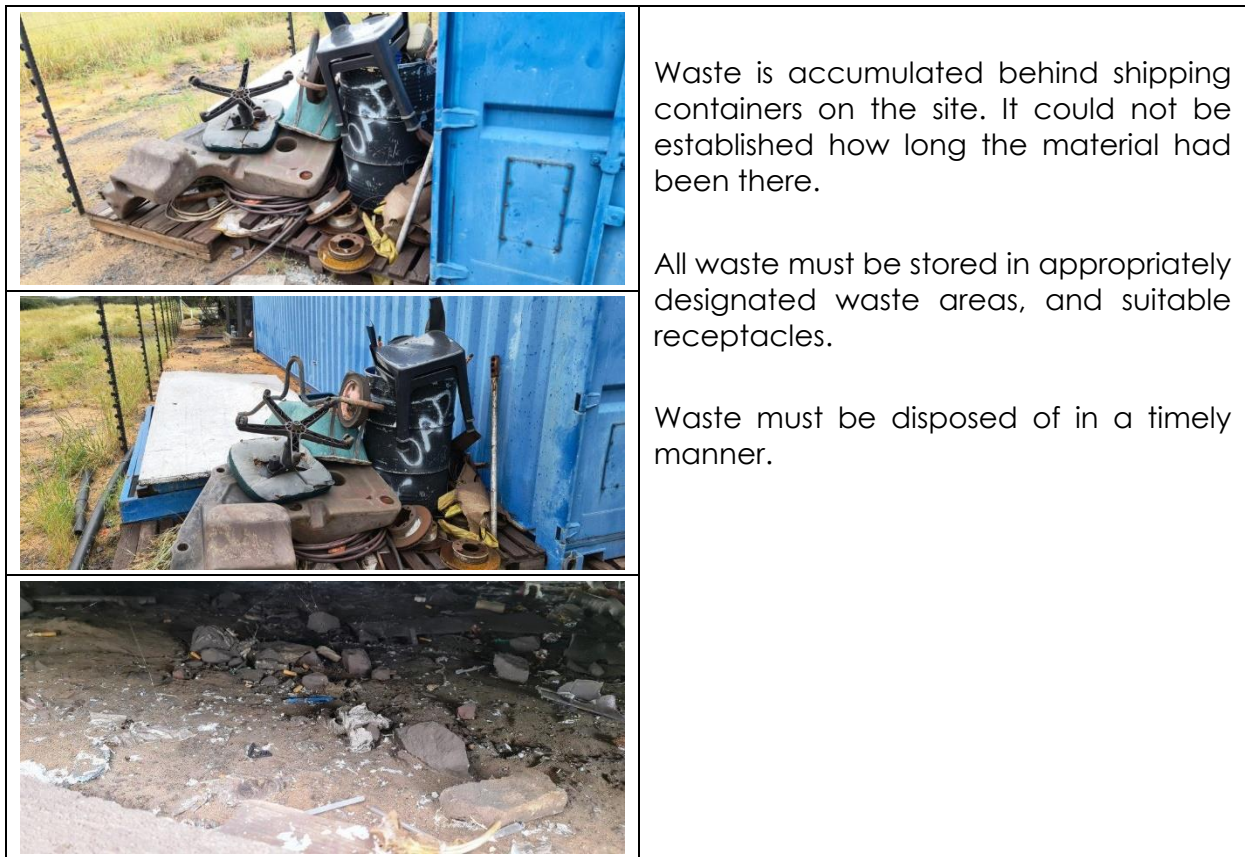
<p>The laydown area only has facilities for accumulation of general waste. General waste is disposed to the BRMO landfill which is not permitted or designed to accept hazardous waste.</p>
 	<p>Hazardous waste was observed in the general waste bins. Fluorescent light tubes contain mercury and other potentially hazardous substances. These tubes must be handled and disposed as hazardous waste.</p>
 	<p>Provision for hazardous waste storage and disposal must be put in place.</p>
<p>Waste bins must also be individually labelled to ensure that it is clear what type of waste belongs in each bin.</p>	
<p>Figure 2-1: TDS - Nchwaning II Laydown – Hazardous Waste Management</p>

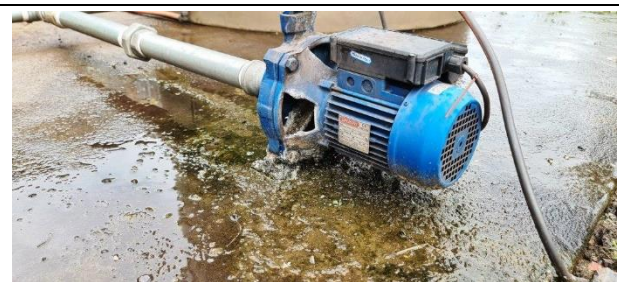
Figure 2-4: TDS - Nchwaning II Laydown – Bund Facility

<p>Potable water is stored in plastic tanks on the site. It was observed that the system is leaking. Algal growth is clear around the pump, implying that the leak has been on-going for a significant period of time.</p>

<p>Water conservation is of significant concern in this water scarce environment.</p> <p>Water leaks must be repaired, and wastage of water must be prevented.</p>

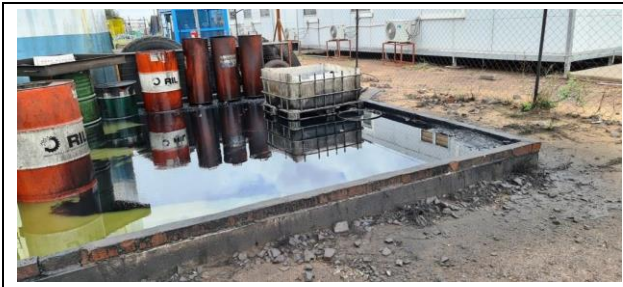
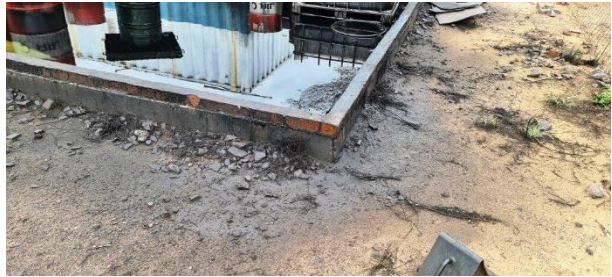
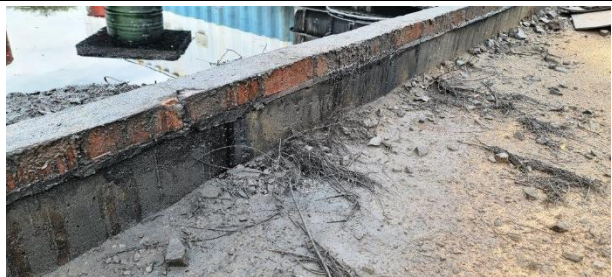
Figure 2-5: Burger & Co - Nchwaning II Laydown – Bund Management

It was clear that the bund at the laydown area has overflowed significantly.

It is likely that contaminated water has not been drained timeously from the bund.

The bund is sloped toward a central sump. If the volume the bund is insufficient for typical downpours experienced at the site then the height of the bund wall should be increased accordingly.

It is recommended that the bund is drained of contaminated water on time to prevent this from recurring.

It is recommended that spills in the bund are cleaned up timeously to minimise the potential for contaminating rain water.

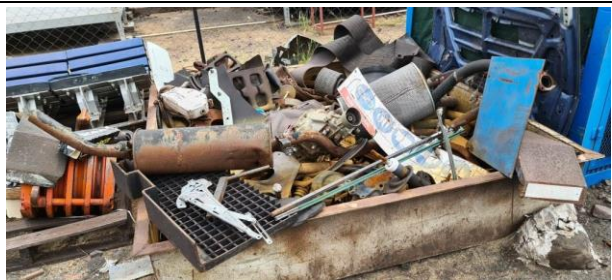
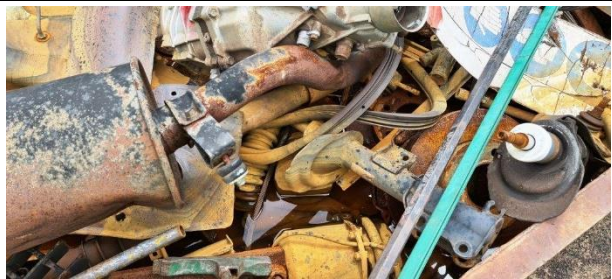
Figure 2-6: Burger & Co - Nchwaning II Laydown – Scrap Metal

The scrap metal container is over flowing. Scrap metal has reportedly not been removed since December 2020.

Waste must be removed from site timeously.

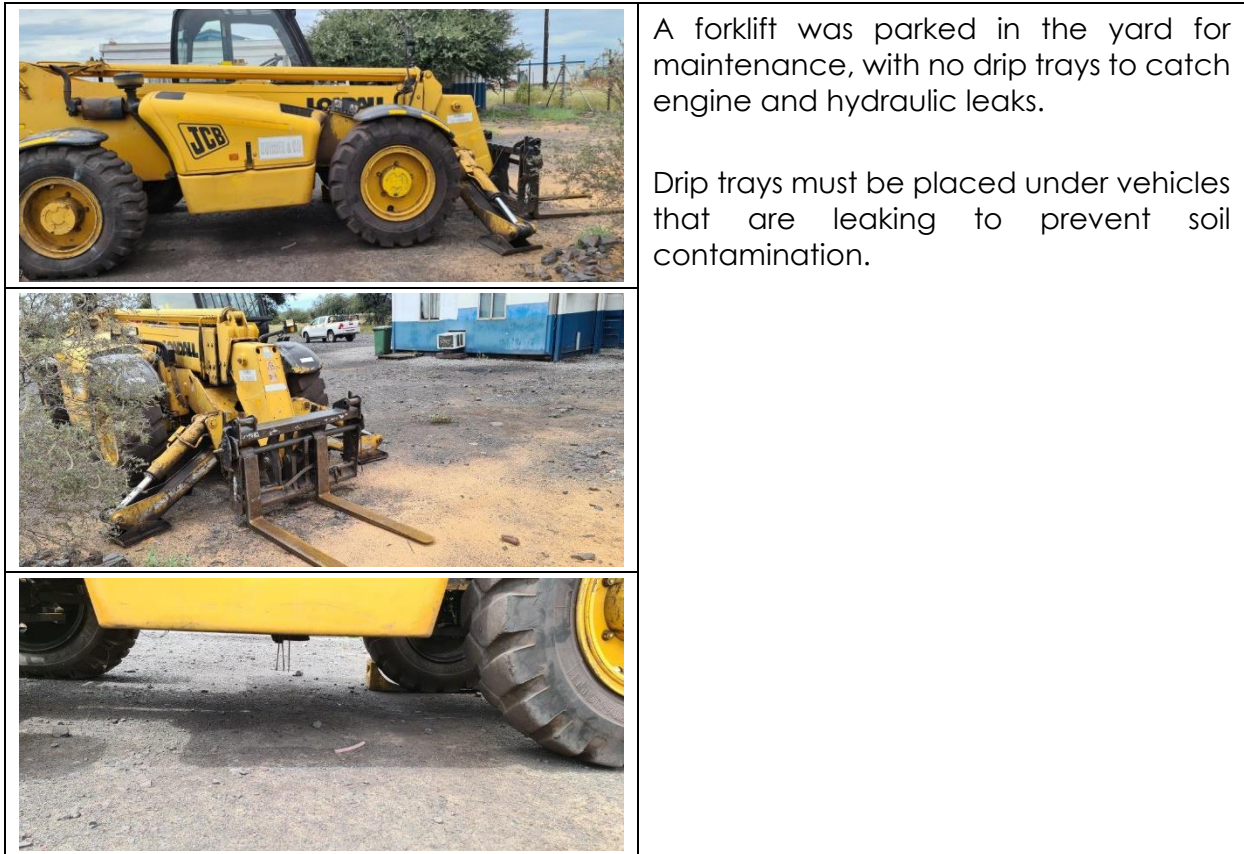
A forklift was parked in the yard for maintenance, with no drip trays to catch engine and hydraulic leaks.

Drip trays must be placed under vehicles that are leaking to prevent soil contamination.

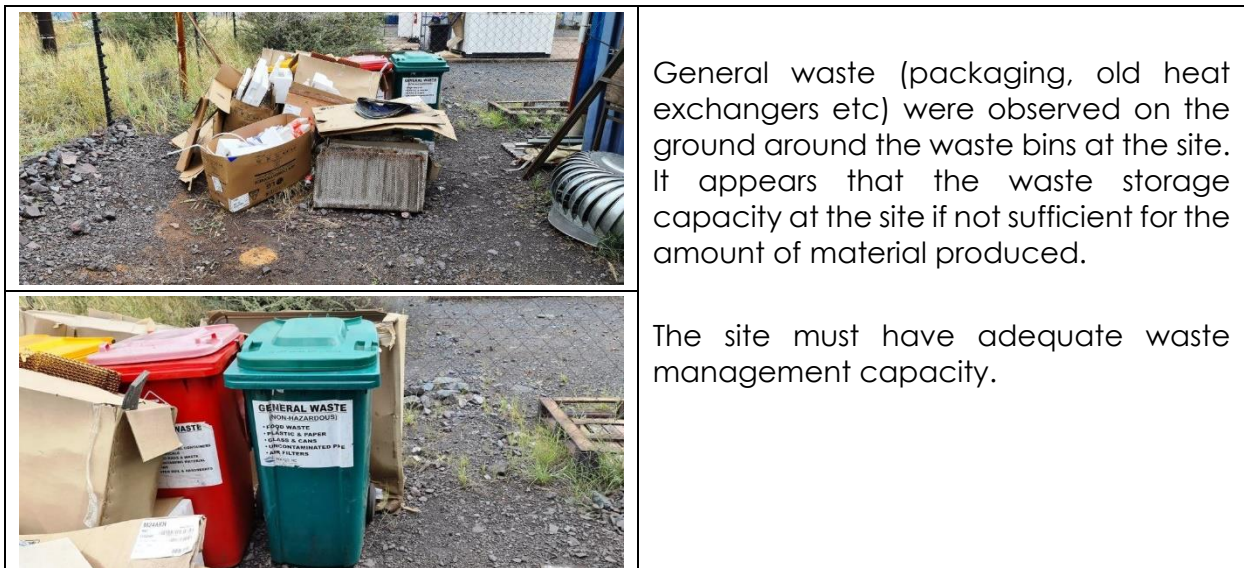
General waste (packaging, old heat exchangers etc) were observed on the ground around the waste bins at the site. It appears that the waste storage capacity at the site is not sufficient for the amount of material produced.

The site must have adequate waste management capacity.

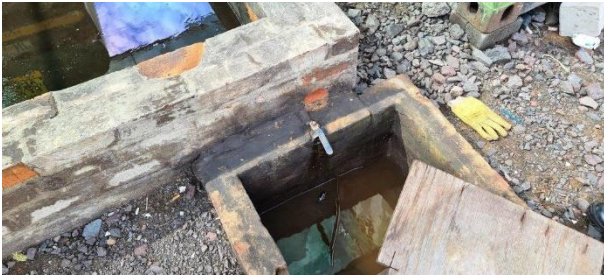
<p>The bund draining valve was found open during the audit. This has been a recurring issue. Leaving the outlet valve open eliminates most of the storage capacity of the bund, and the bund is thus ineffectual for a large spill.</p> <p>The draining valve must always be closed and locked unless the bund is being drained.</p>
<p>Figure 2-9: Olivier - Nchwaning II Laydown – Bund drain valve open</p>

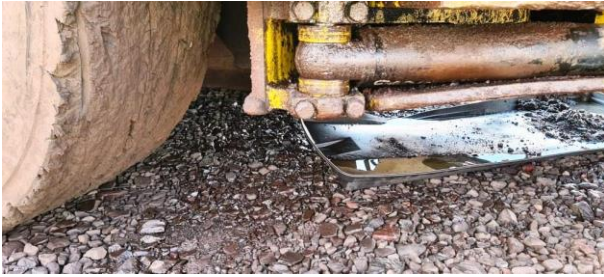
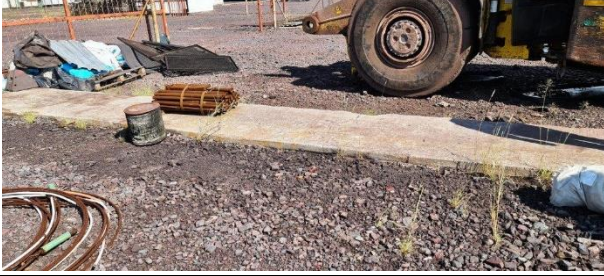
<p>The management of spills and leaks at this site is a concern. Spills and soil contamination on the site have been noted during several audits. Although there is often an improvement after an audit, there is often a revert to observing contamination at subsequent audits.</p>

<p>The contractor must ensure that adequate measures are in place to prevent and contain spills and leaks and that these are enforced at the site.</p>
<p>Figure 2-10: Tau Diphoka - Nchwaning II Laydown</p>
