FINAL EXTERNAL WATER USE LICENCE COMPLIANCE AUDIT REPORT FOR ASSMANG MANGANESE (PTY) LTD - BLACK ROCK MINE OPERATIONS (BRMO), HOTAZEL, NORTHERN CAPE

LICENCE NO: 10/D41M/ABEGJ/3490
MC PROJECT CODE: 201910

Date: July 2019

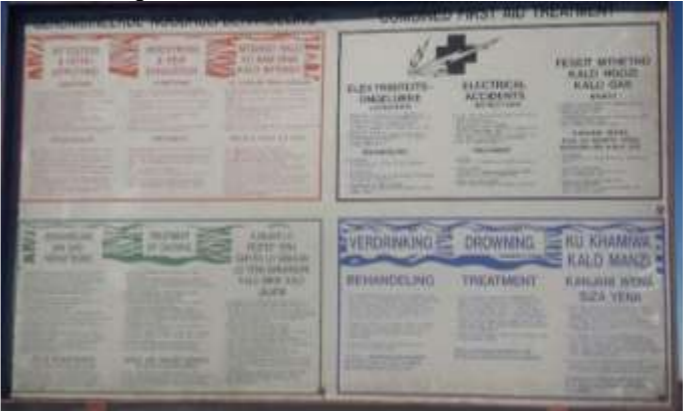
7.3.	Notices manufactured of a durable weather-proof material warning against the use of water containing waste for drinking and washing purposes must be displayed at prominent places where the waste is being reused and at all taps. Such notices shall be worded in the official languages applicable in the area.	√ In Place	√ In Place	Licence Holder i.e. Assmang: BRMO	Conspicuous signage is in place to distinctively show drinkable and not drinkable water. These notices are all written in English, Afrikaans and Setswana.

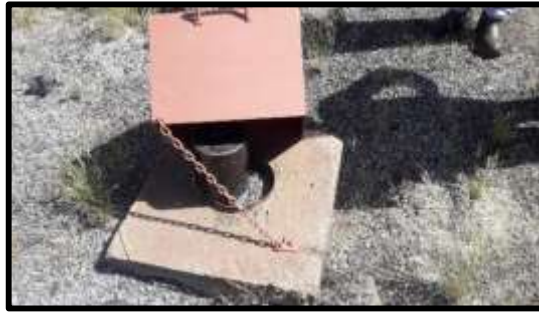
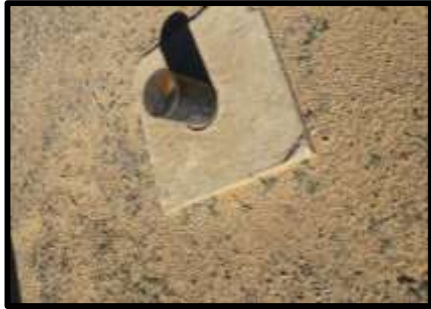
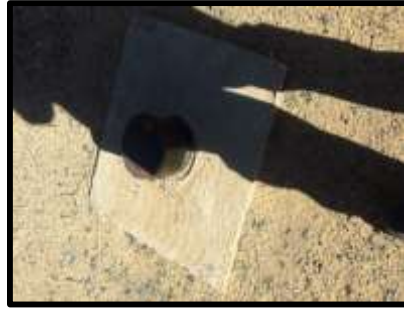
MONITORING BOREHOLES

Monitoring boreholes located at three different mining operations (Black Rock Mine / Nchwaning complex / Gloria Mine)

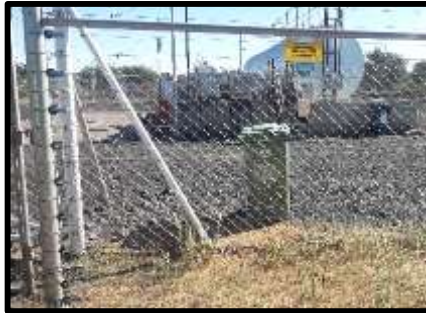
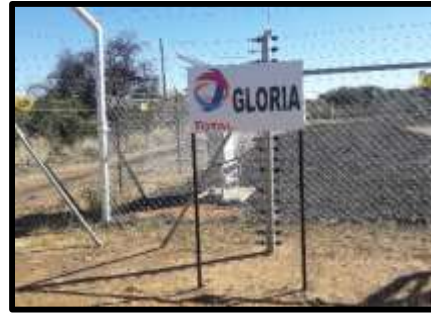
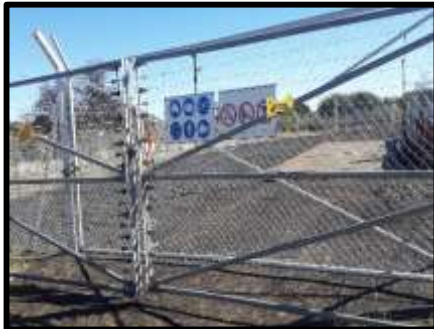
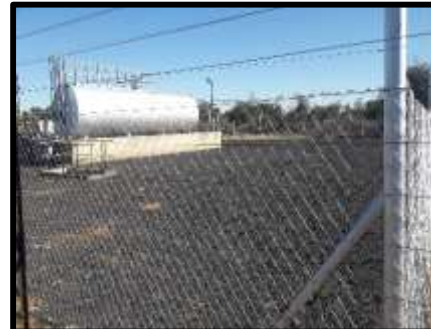
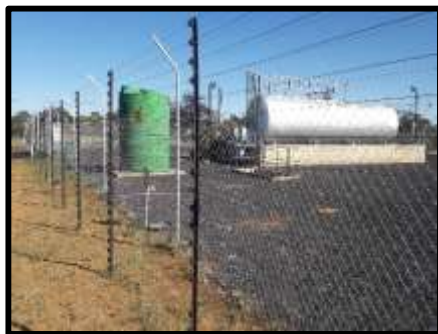
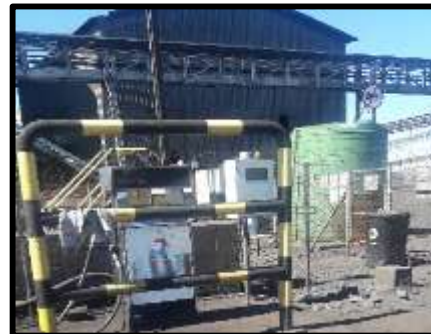
BULK FUEL STORAGE AND REFUELLING STATIONS

All of the hazardous substances are handled according to the relevant legislation. The bunded areas under the diesel storage tanks do not allow seepage through the bund walls. All the bunded areas under the diesel pumps are in good condition, except that a fuel spillage outside of the concrete lined filling station at Nchwaning II was noted, which had not been cleaned up. It is understood that the filling station is in the process of being decommissioned and relocated.

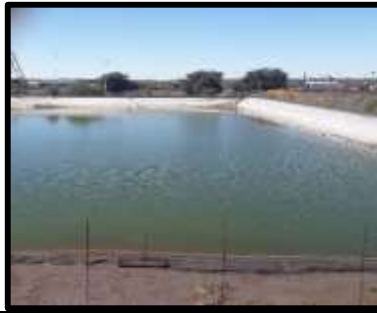
RETURN WATER DAMS

Water containing waste being disposed into return water dams

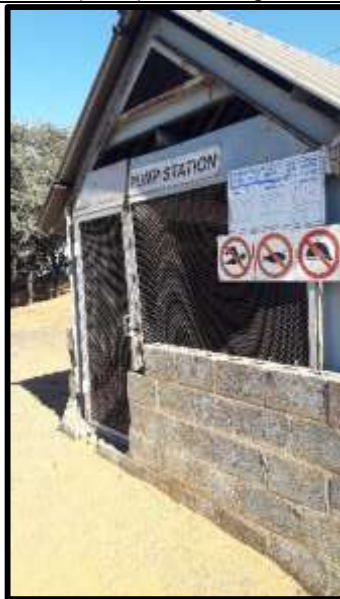
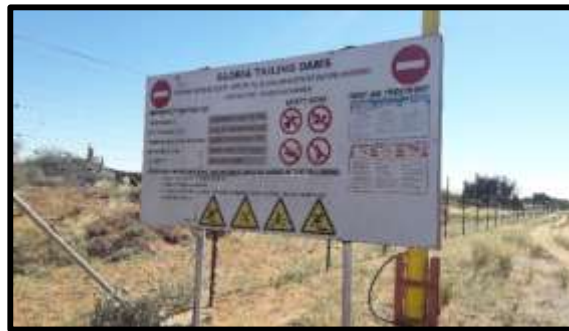
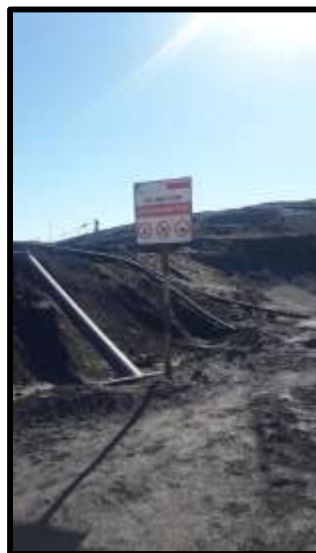
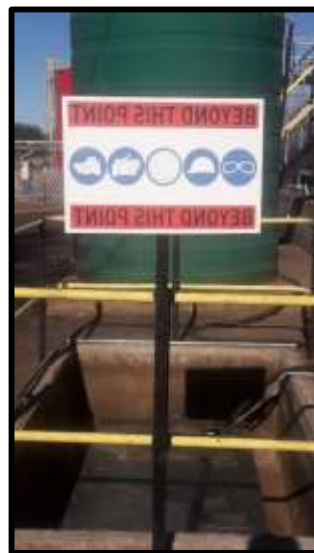
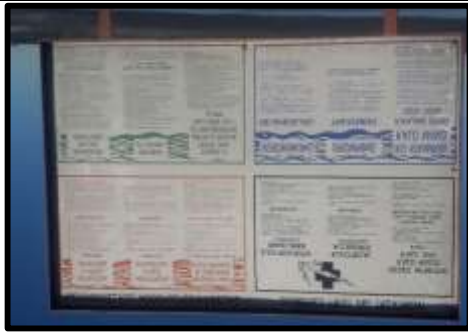
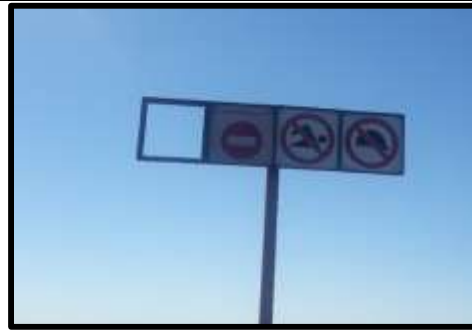
SAFETY/ WARNING/ INFORMATIVE SIGNAGE

Notices manufactured of a durable weather-proof material warning against the use of water containing waste for drinking and washing purposes being displayed at prominent places where the waste is being reused and at all taps worded in the official languages applicable in the area.

Appropriate warning signs erected all around the mine.

Notices prohibiting unauthorised persons from entering the certain areas, as well as internationally acceptable signs indicating the risks involved in case of an unauthorised entry were displayed along the boundary fence of all mines and its facilities. Safety signs were noted in place at various locations around the mine, including the Tailings Storage Facilities (TSFs) and Sewage Treatment Plants (STPs).

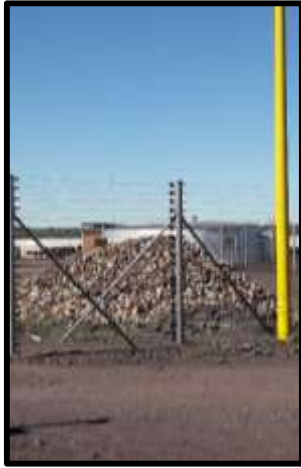
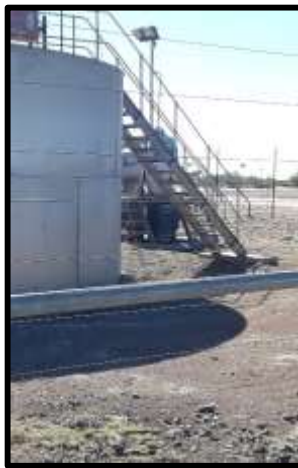
RESERVOIRS

Potable water reservoir (roofed) being used for human consumption, ablutions and emergency fire tanks.

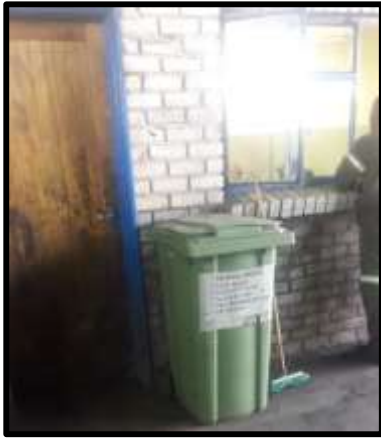
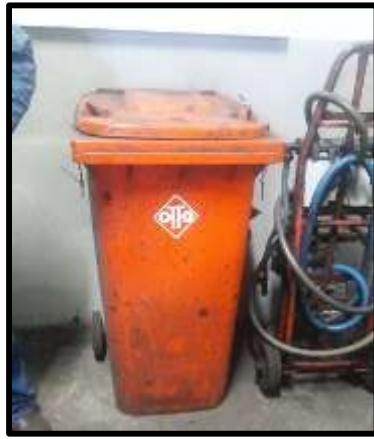
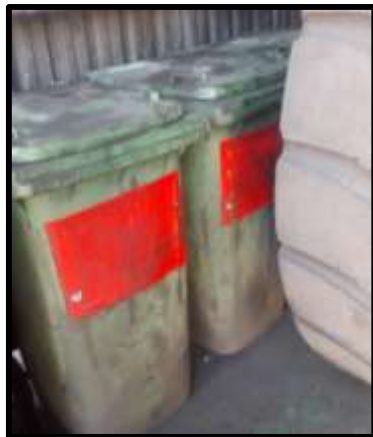
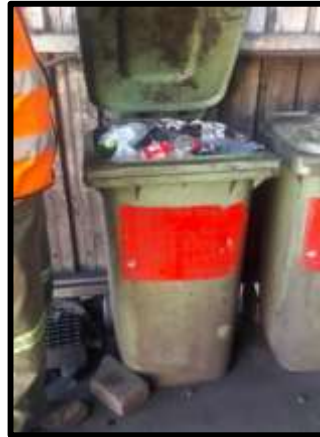
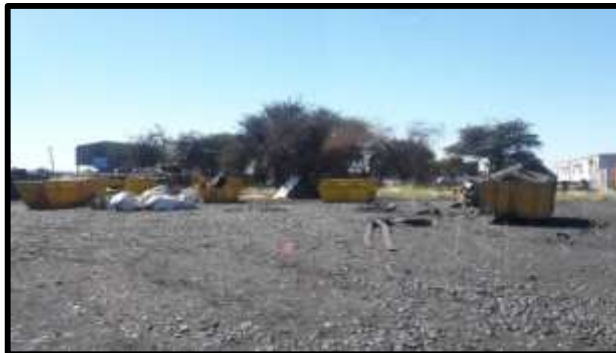
WASTE MANAGEMENT

Waste bins and skips strategically placed in all working areas

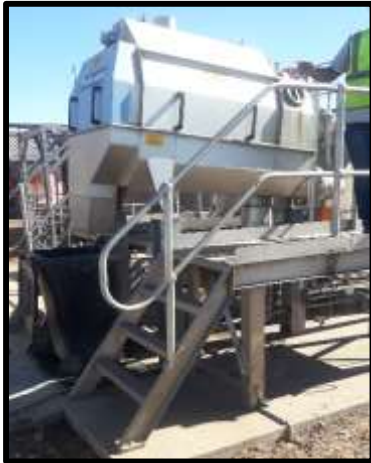
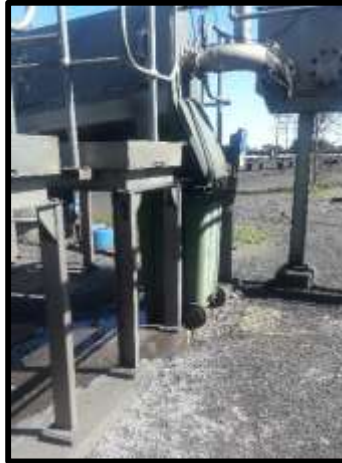
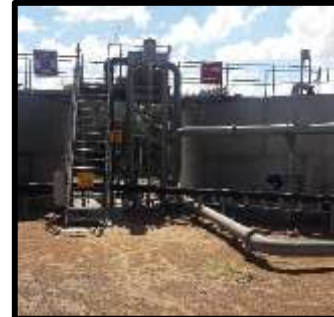
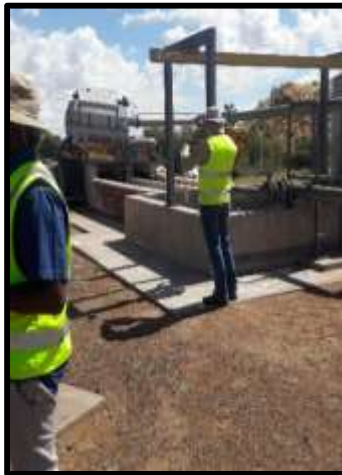
WASTE WATER TREATMENT

The STPs at Black Rock, Nchwaning II and Gloria. The STPs at Nchwaning II and Gloria were noted to be actively spilling onto bare ground during the audit.

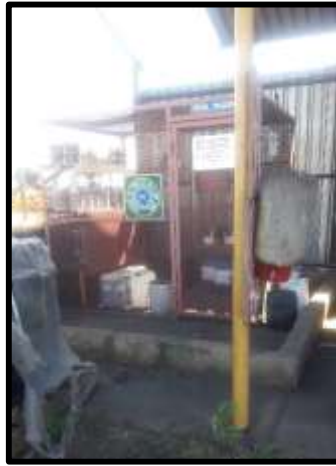
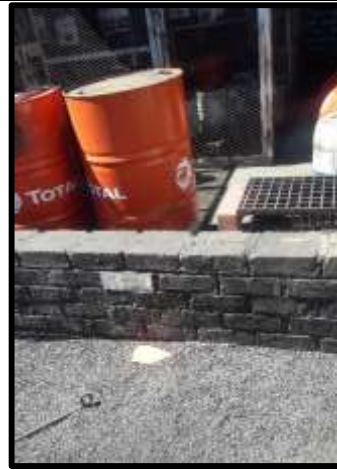
HAZARDOUS SUBSTANCES STORAGE

All reagent storage tanks and reaction units have been supplied with a bunded area built to the capacity of the facility and provided with sumps. .

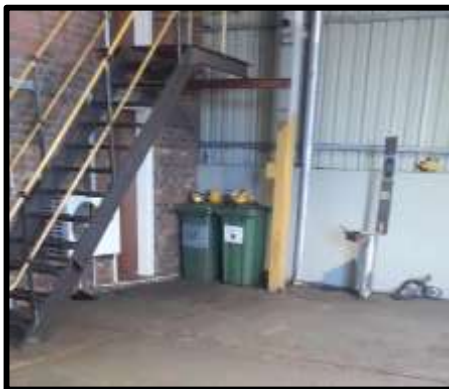
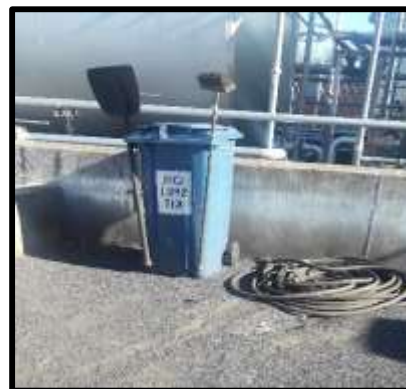
SPILL KITS

Spill management kits are being kept and maintained on site wherever liquid hazardous materials are stored, and where refuelling and /or servicing of plant, vehicles and machinery takes place.

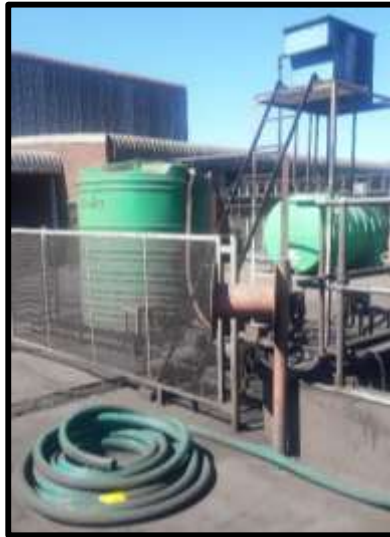
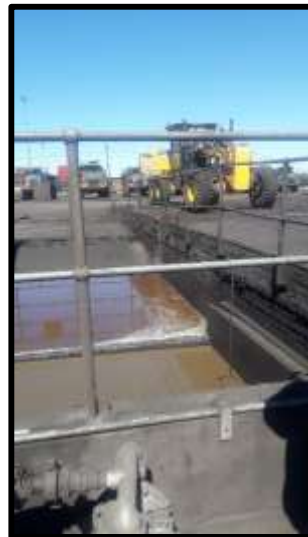
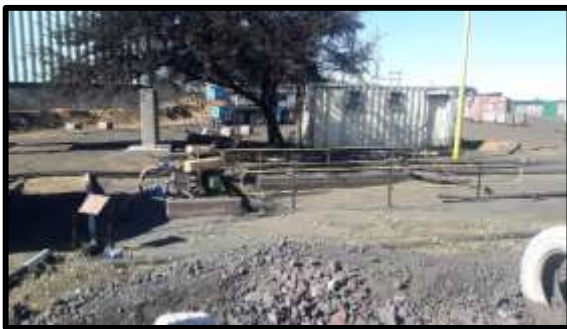
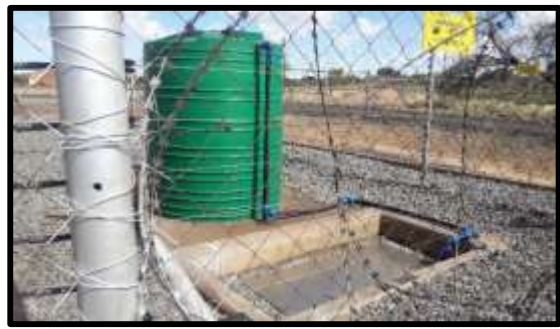
WATER CONSERVATION OIL AND WATER SEPERATORS

Storm water infrastructure is in place. Contaminated water from process works at all mining areas is being collected into the process water circuit. The water is transported from the processing works, to settling plants for further processing, and is directed back to the mines for re-use. In cases were water is mixed with oils/ hazardous substances, the water is decanted into the oil/water separator. The separated is temporarily stored in JoJo tanks for re-use.

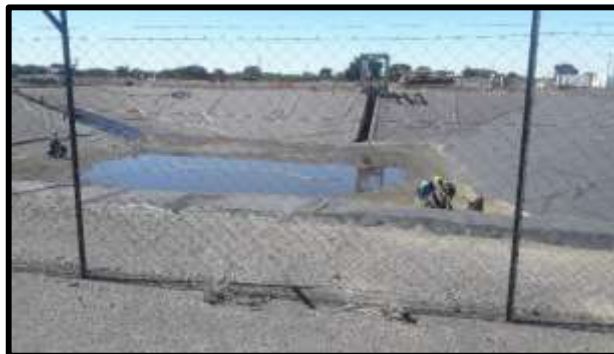
STORMWATER COLLECTION DAMS

No storm water management measures (clean or affected water) are implemented at BRMO. Clean storm water runoff and rainfall are not diverted away from the operation or contained once within the operational area. Storm water runoff is allowed flow along the natural topography and discharge to the receiving environment, except at Nchwaning II, the original TSF constructed in 2018 is now being used as a storm water catchment dam. The storm water catchment dam will allow for the contaminated storm water to be intercepted by canals and diverted to the newly installed storm water catchment dam for re-use during dust suppression.

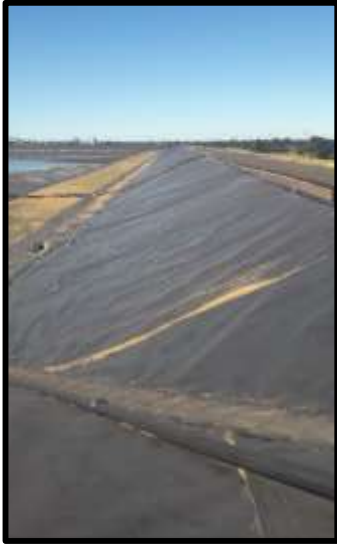
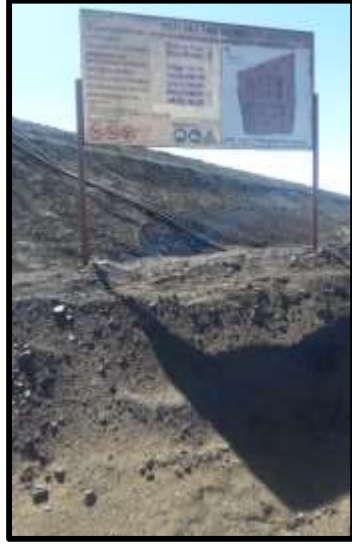
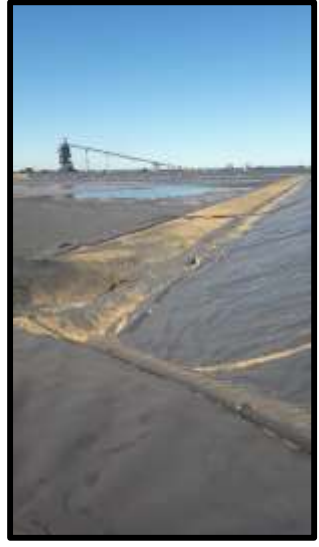
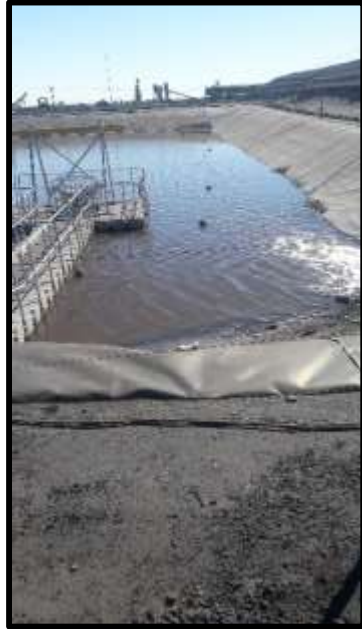
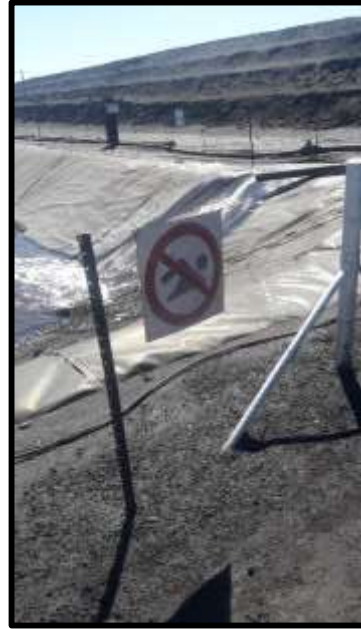
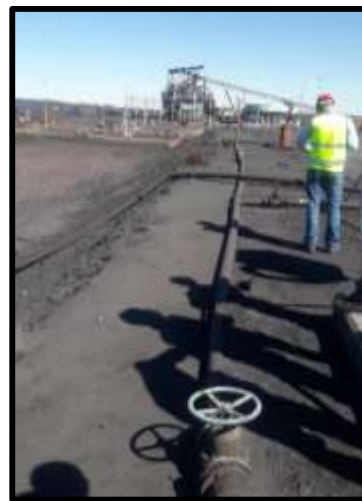
POLLUTION CONTROL AND SLIMES DAMS

All pollution control dams and slimes dams are fenced off. A freeboard of 0.8 m was not apparent at certain sections along the top of the Nchwaning II slimes dams.

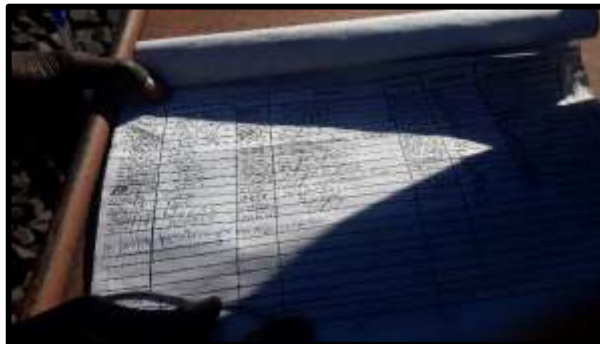
SITE DOCUMENTATION

Averyone entering the dams areas are being made to sign the register.

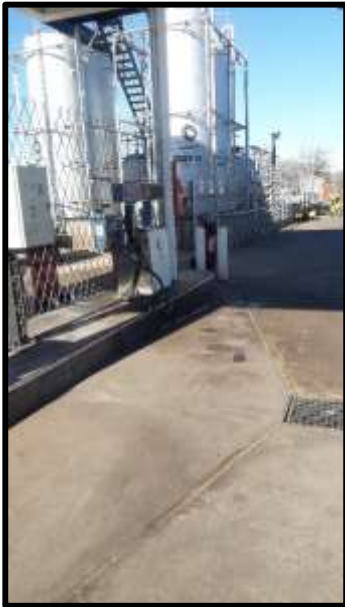
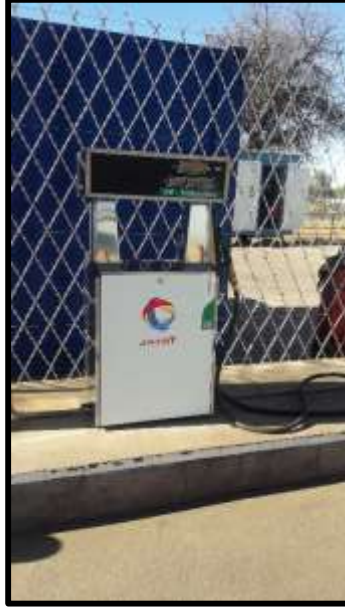
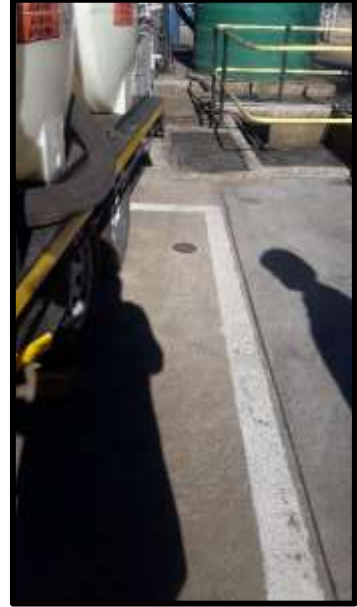
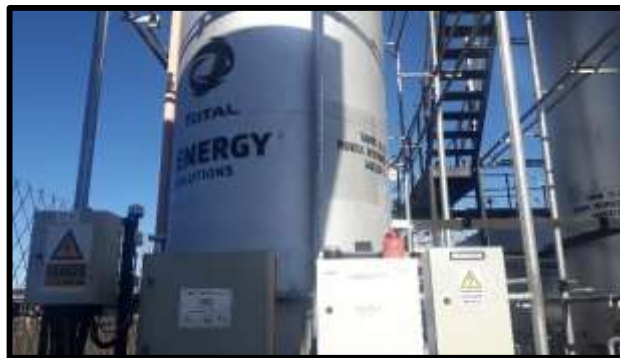
TOTAL FILLING STATION

The total Filling Station at Nchwaning III complied with all the relevant legislation.

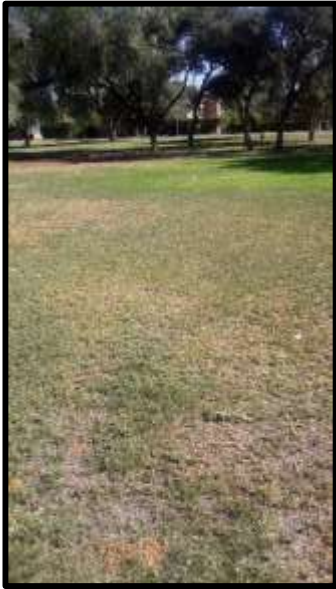
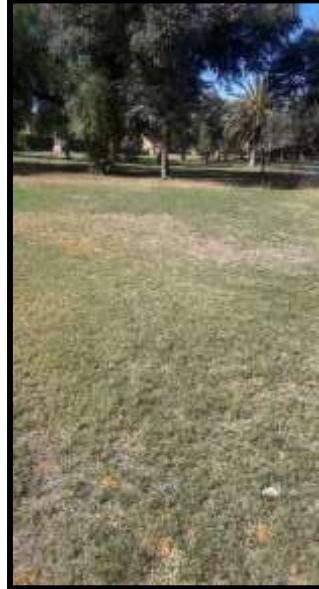
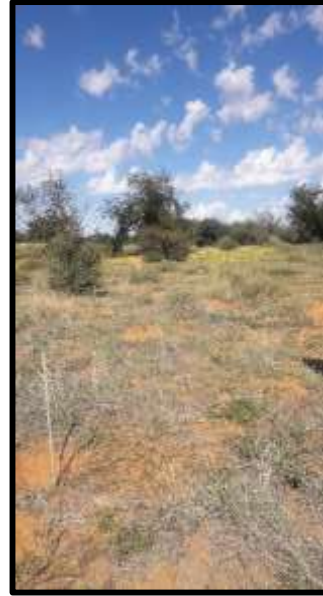
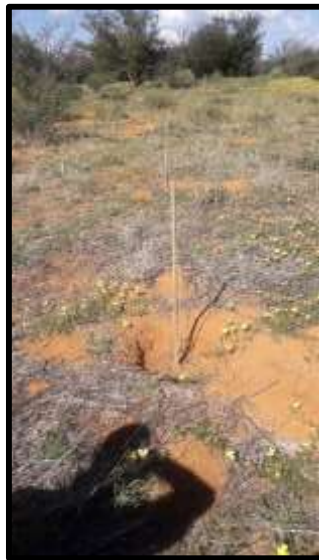
SITES BEING IRRIGATED

Potable water is being used to irrigate the golf course (only in areas where 750 trees have been planted). Irrigation of the golf course with waste water is therefore no longer happening, but rather only the irrigation of the villages parks and sports fields takes place.
