KHUMANI IRON ORE MINE

KING PDF

DAM BREAK ANALYSIS - 2021

Report prepared for

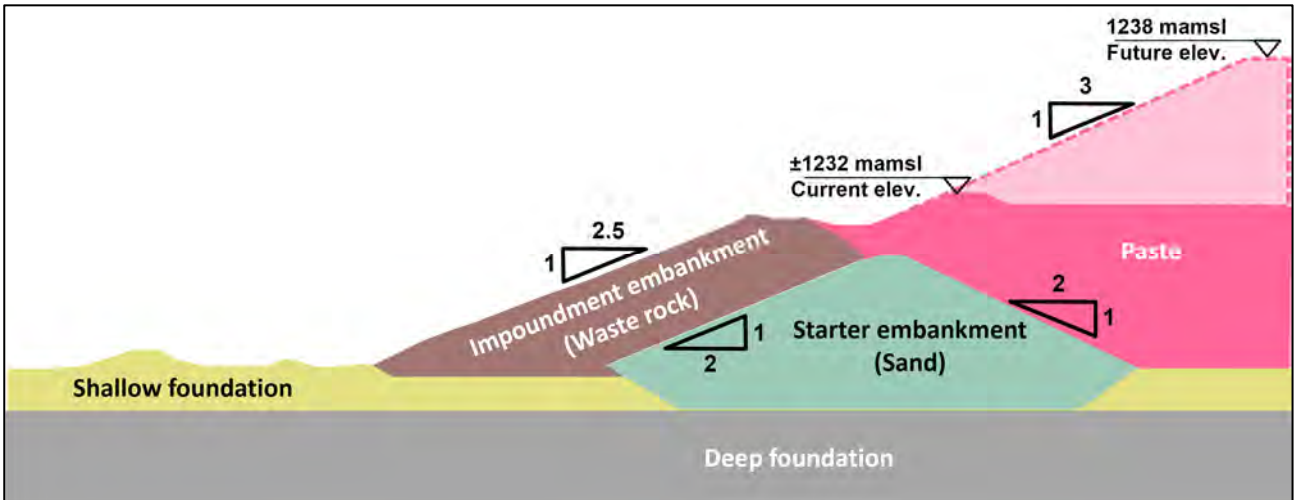
FIGURE 4: KING PDF CONSTRUCTION MATERIALS

The construction material used to form the outer embankments that face the N14 highway are shown in Figure 4.

The tailings are deposited as a dewatered paste. The allowable rate of rise is limited to less than 1 m per year to allow for desiccation of the paste.

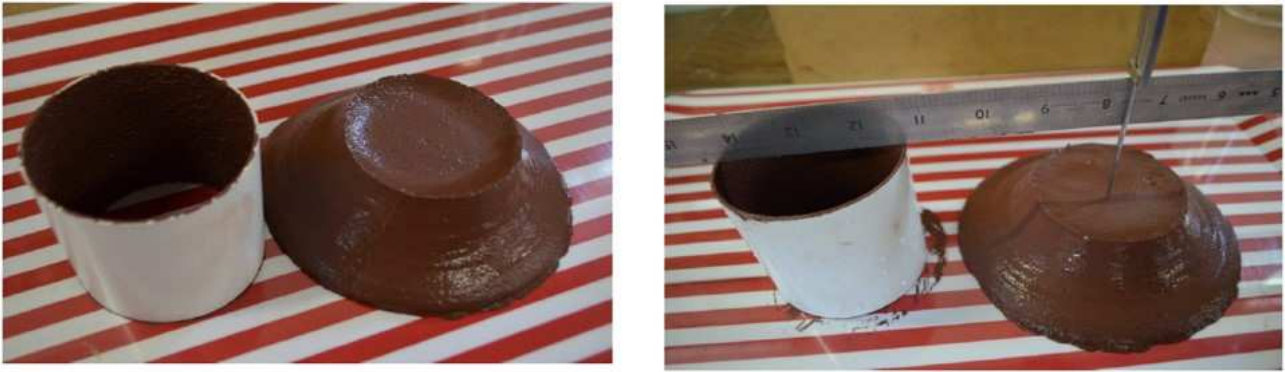
FIGURE 7: BOGER SLUMP TEST

- A Paterson & Cooke Slurry Test Work report dated 2005 provides data on the specific gravity of the tailings particles as well as regression equations for the Bingham Plastic model parameters versus solids concentration.
- Tailings properties provided by Khumani Mine (2017 – 2019) and used in Geo Tail's annual audit reports.
- Three Boger slump tests performed by BM du Plessis Civil Engineering (2019).

Discrepancies were noted when the specific gravity, and the Yield Stress of the in-situ material stated in the Patterson & Cooke test work and the Boger slump test sources were compared. The specific gravity results of the two more recent data sources agreed.

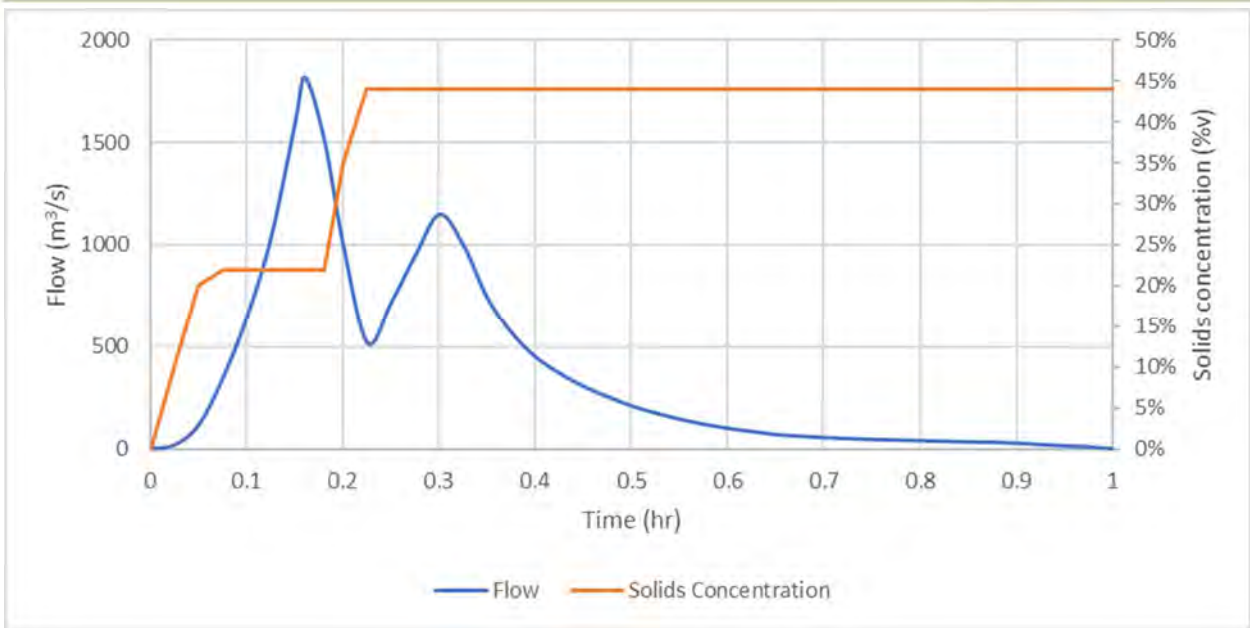
FIGURE 9: RAINY DAY FLOOD HYDROGRAPH (COMPARTMENT 1)

If poor water management on the PDF occurs and large pools develop on the PDF, this failure mode would likely be triggered by an extreme storm such as the 10 000-yr storm. This process results in a two-wave hydrograph, i.e., two flood peaks. The initial water outflow is the first flood peak and then the tailings/water mixture outflow is the second flood peak. In the case of the PDF, the first flood peak is the larger of the two flood peaks and will have the largest zone of influence. The Ga-Mogara River is downstream of the PDF and water that is discharged from the PDF will flow into the Ga-Mogara River and create flood conditions in the river.

The resulting flood hydrographs and associated solids concentrations for compartments 1 and 2 are shown in Figure 9 and Figure 10. The rainy-day peak flows are very similar for the current height and final height scenarios. The rainy-day simulations and results are applicable to both current height and final height scenarios.

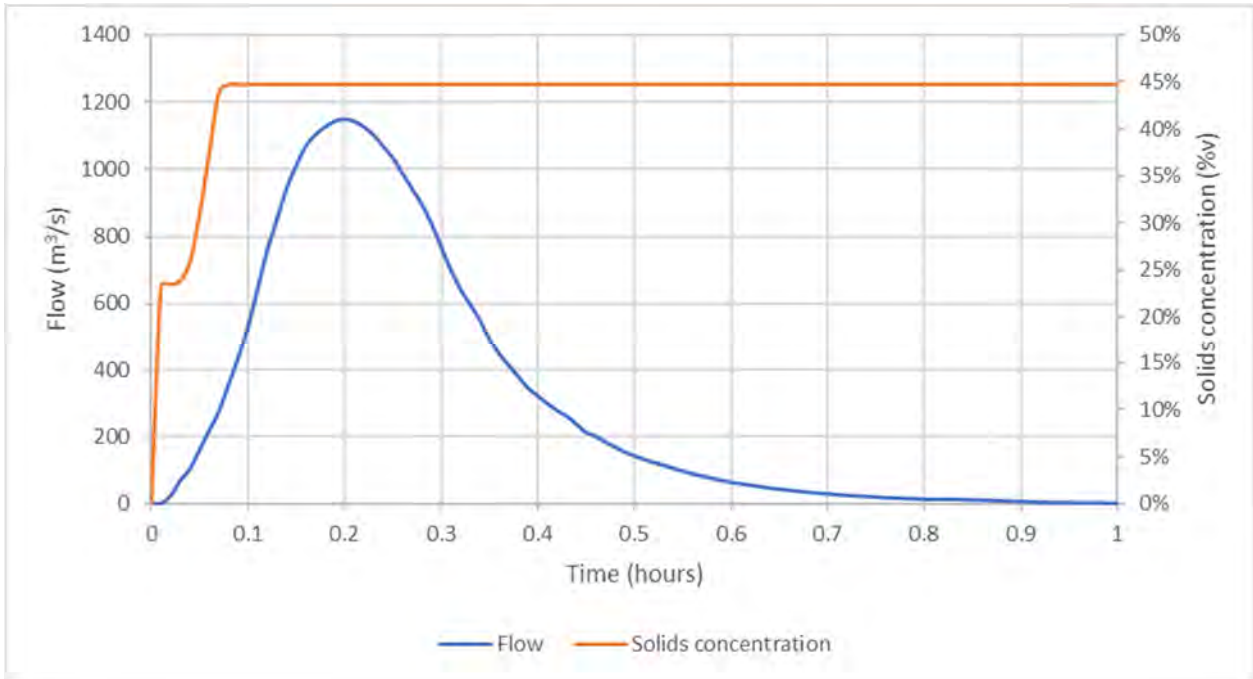
FIGURE 11: SUNNY DAY FLOOD HYDROGRAPH (COMPARTMENT 1)

The geotechnical test work done to date (refer to Section 2.2) shows that the paste will contract when sheared. It is therefore assumed that the paste is liquefiable. The sunny day failure is considered a credible failure mode for the final height scenario.

The resulting flood hydrographs and associated solids concentrations for compartments 1 and 2 are shown in Figure 11 and Figure 12.

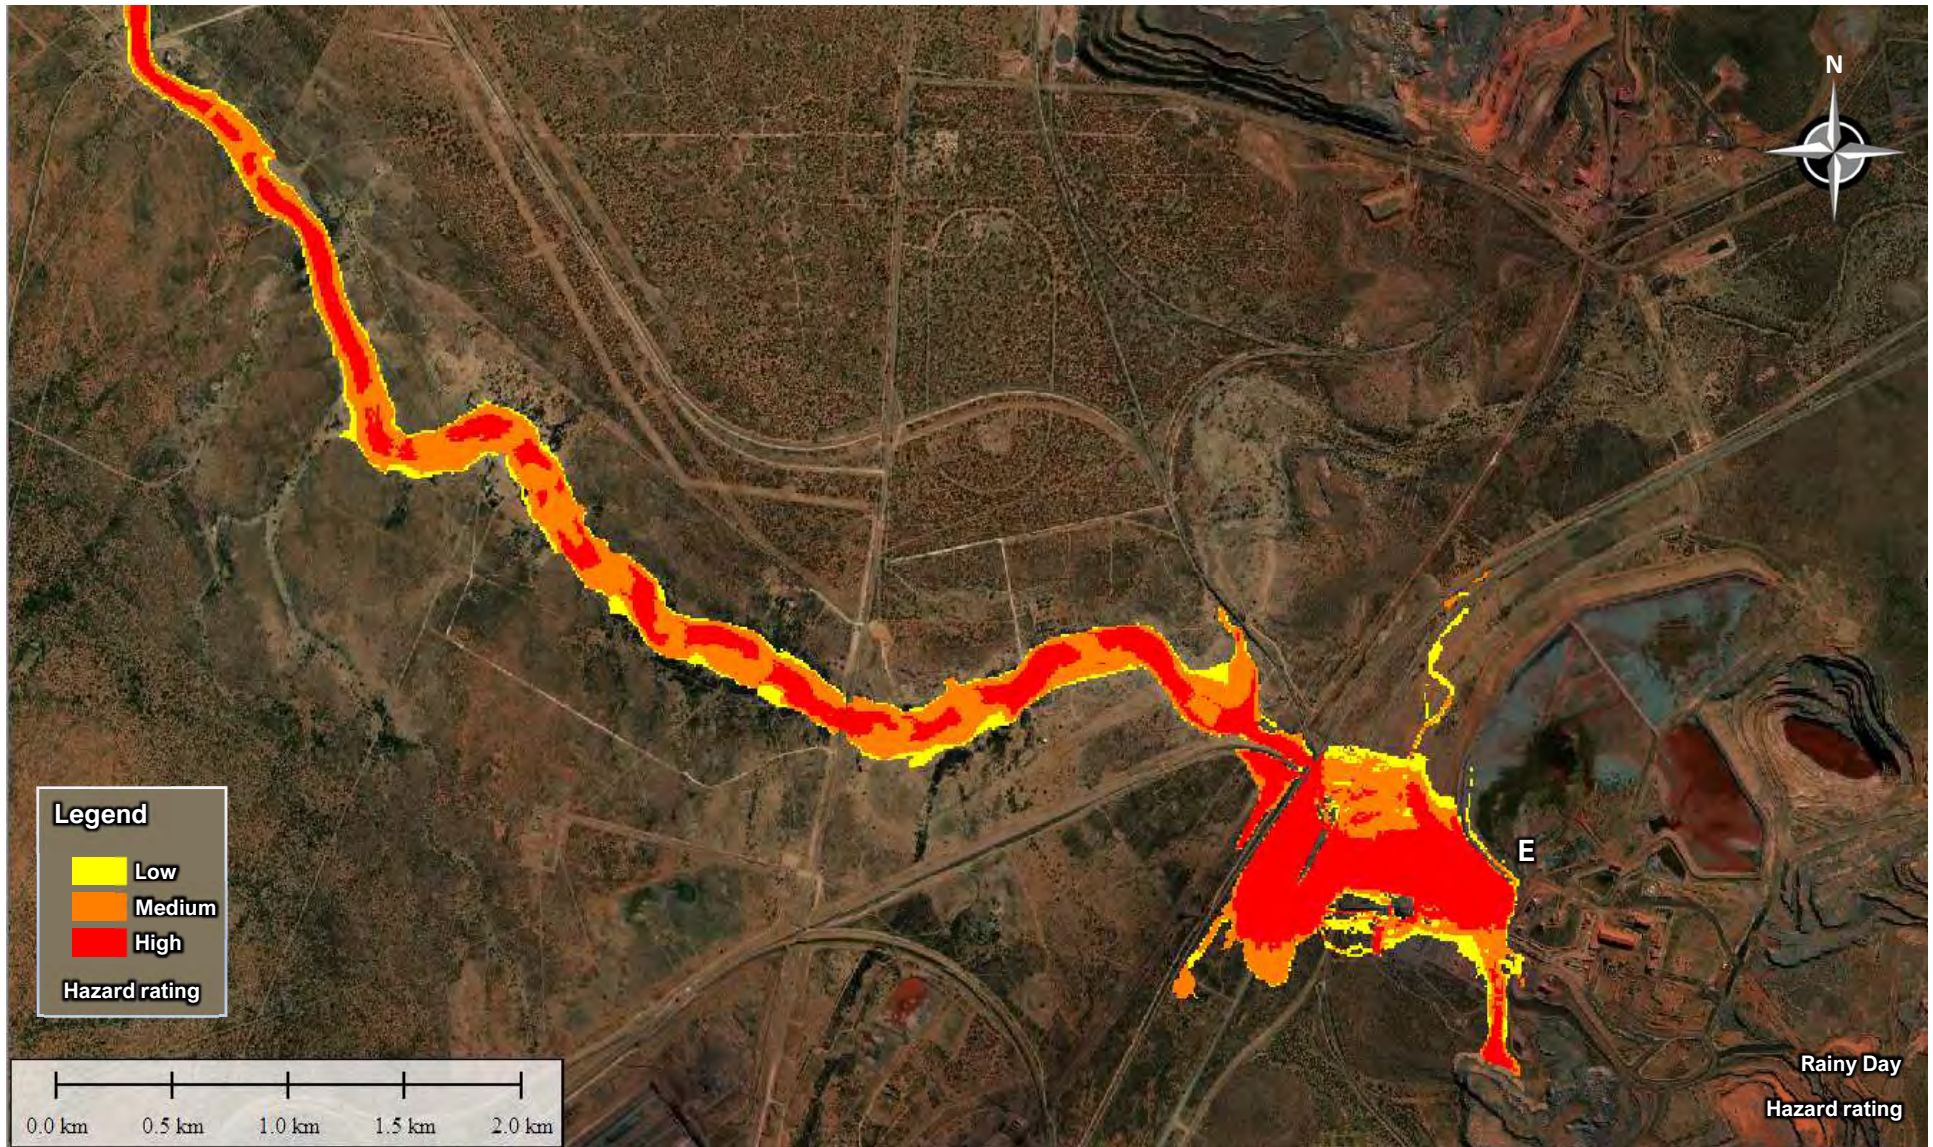
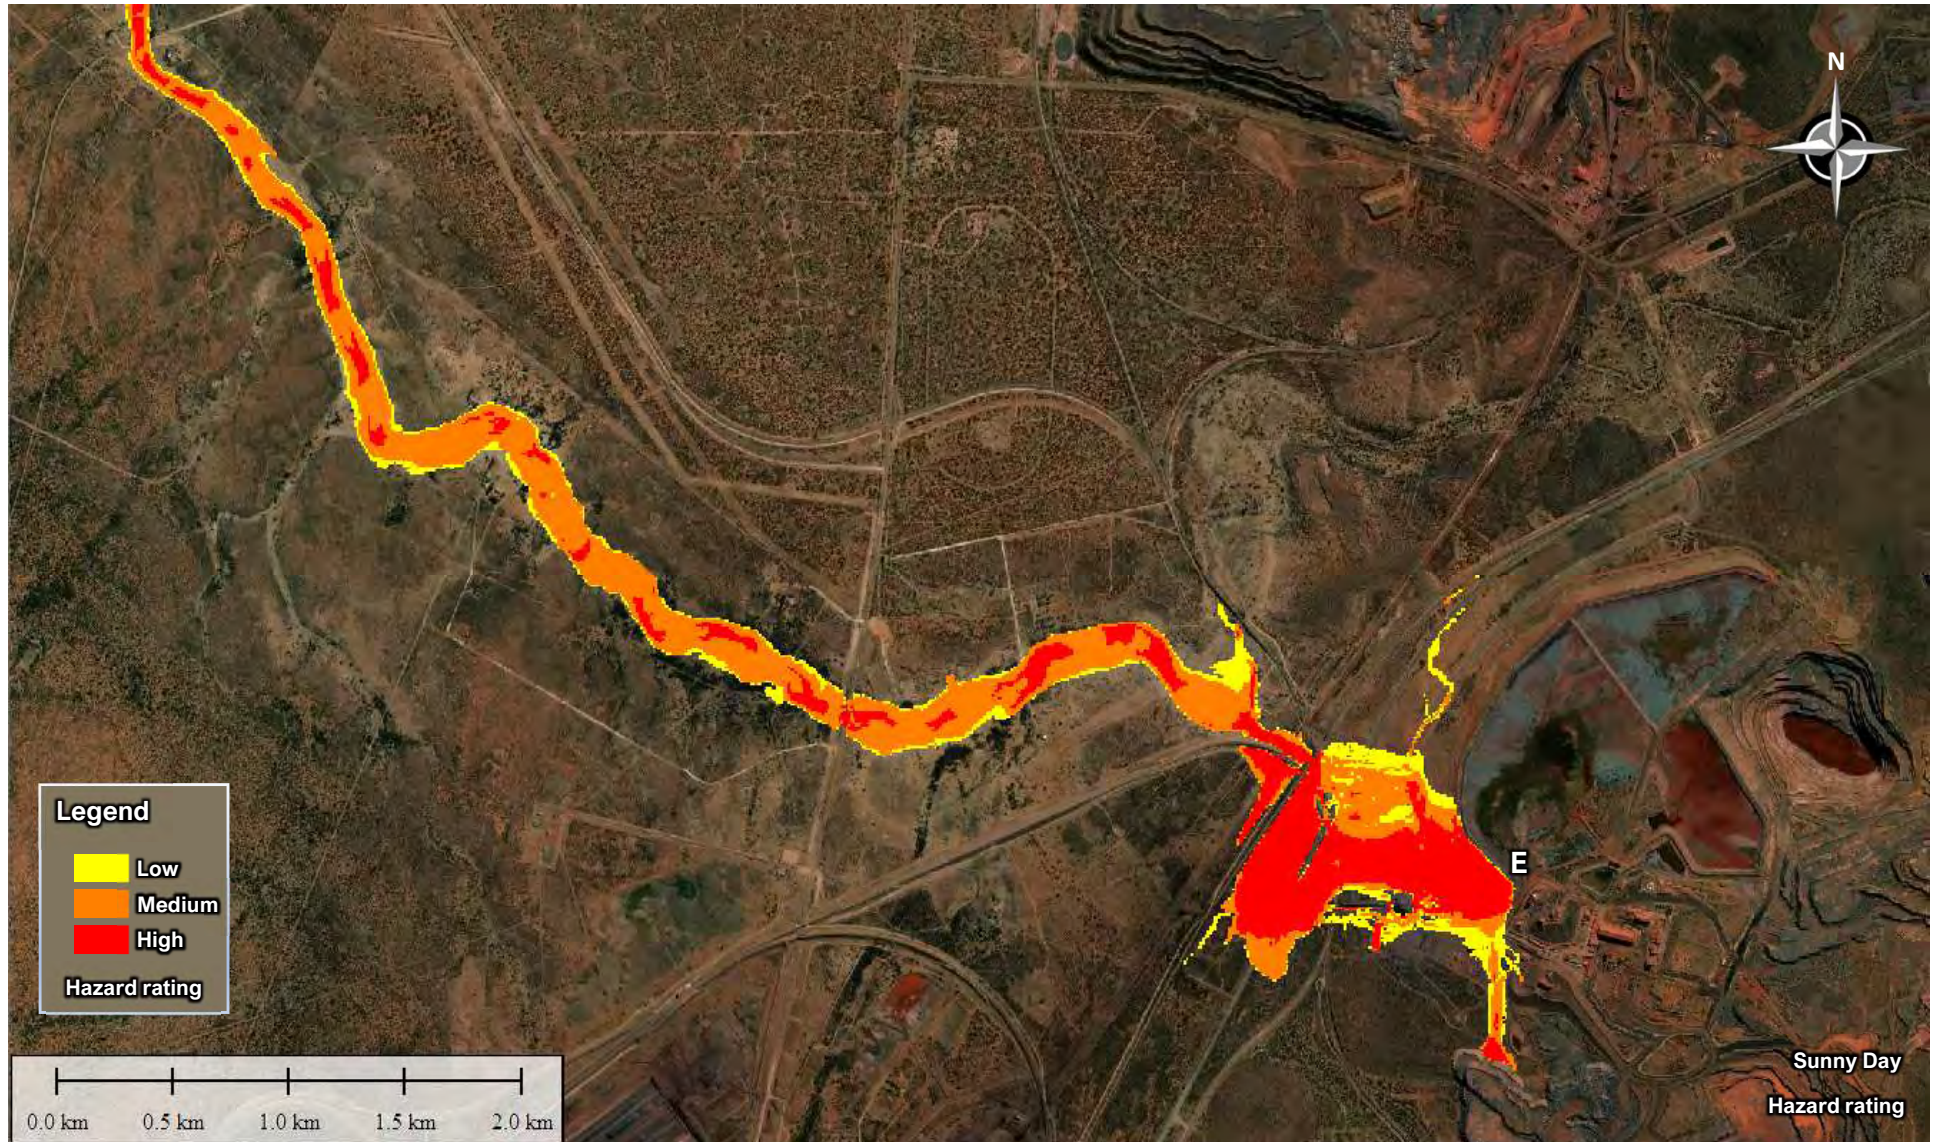
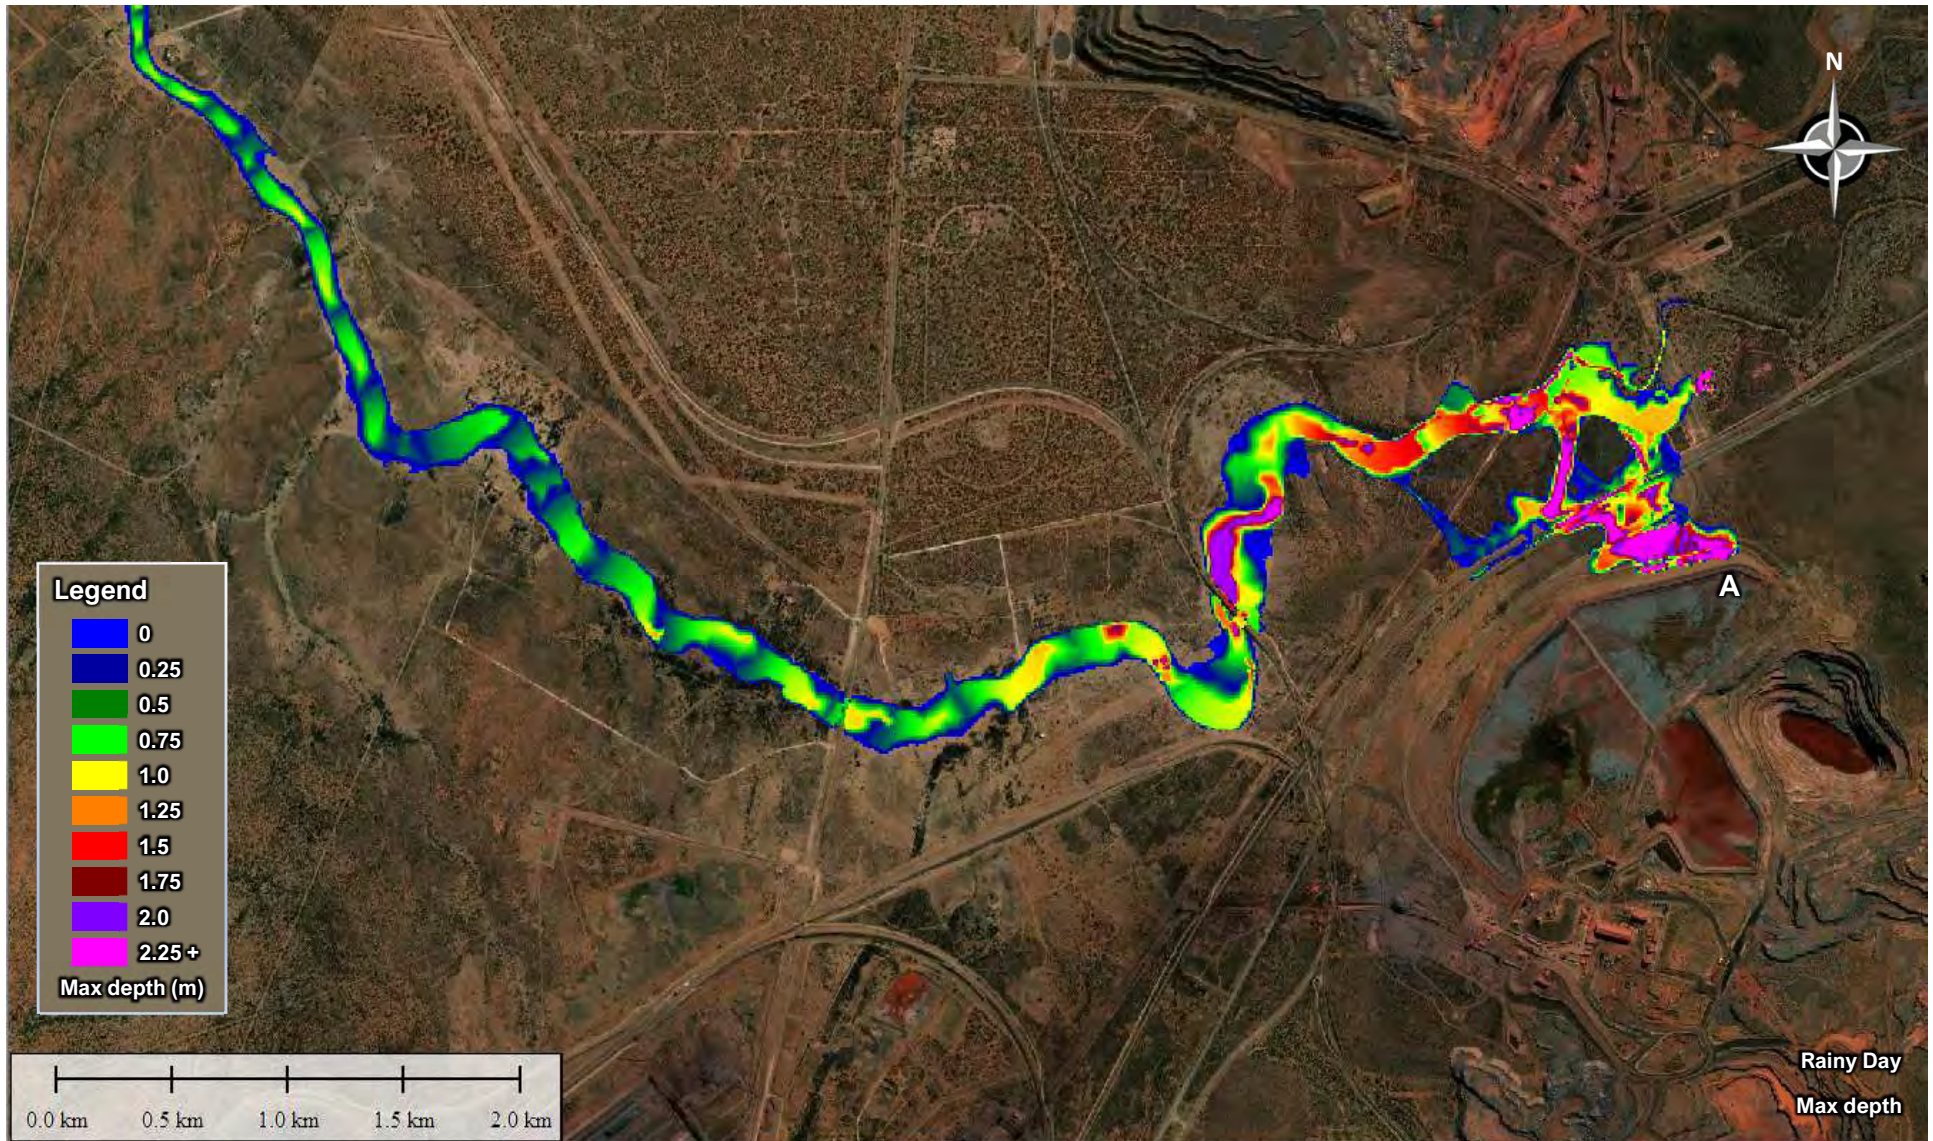
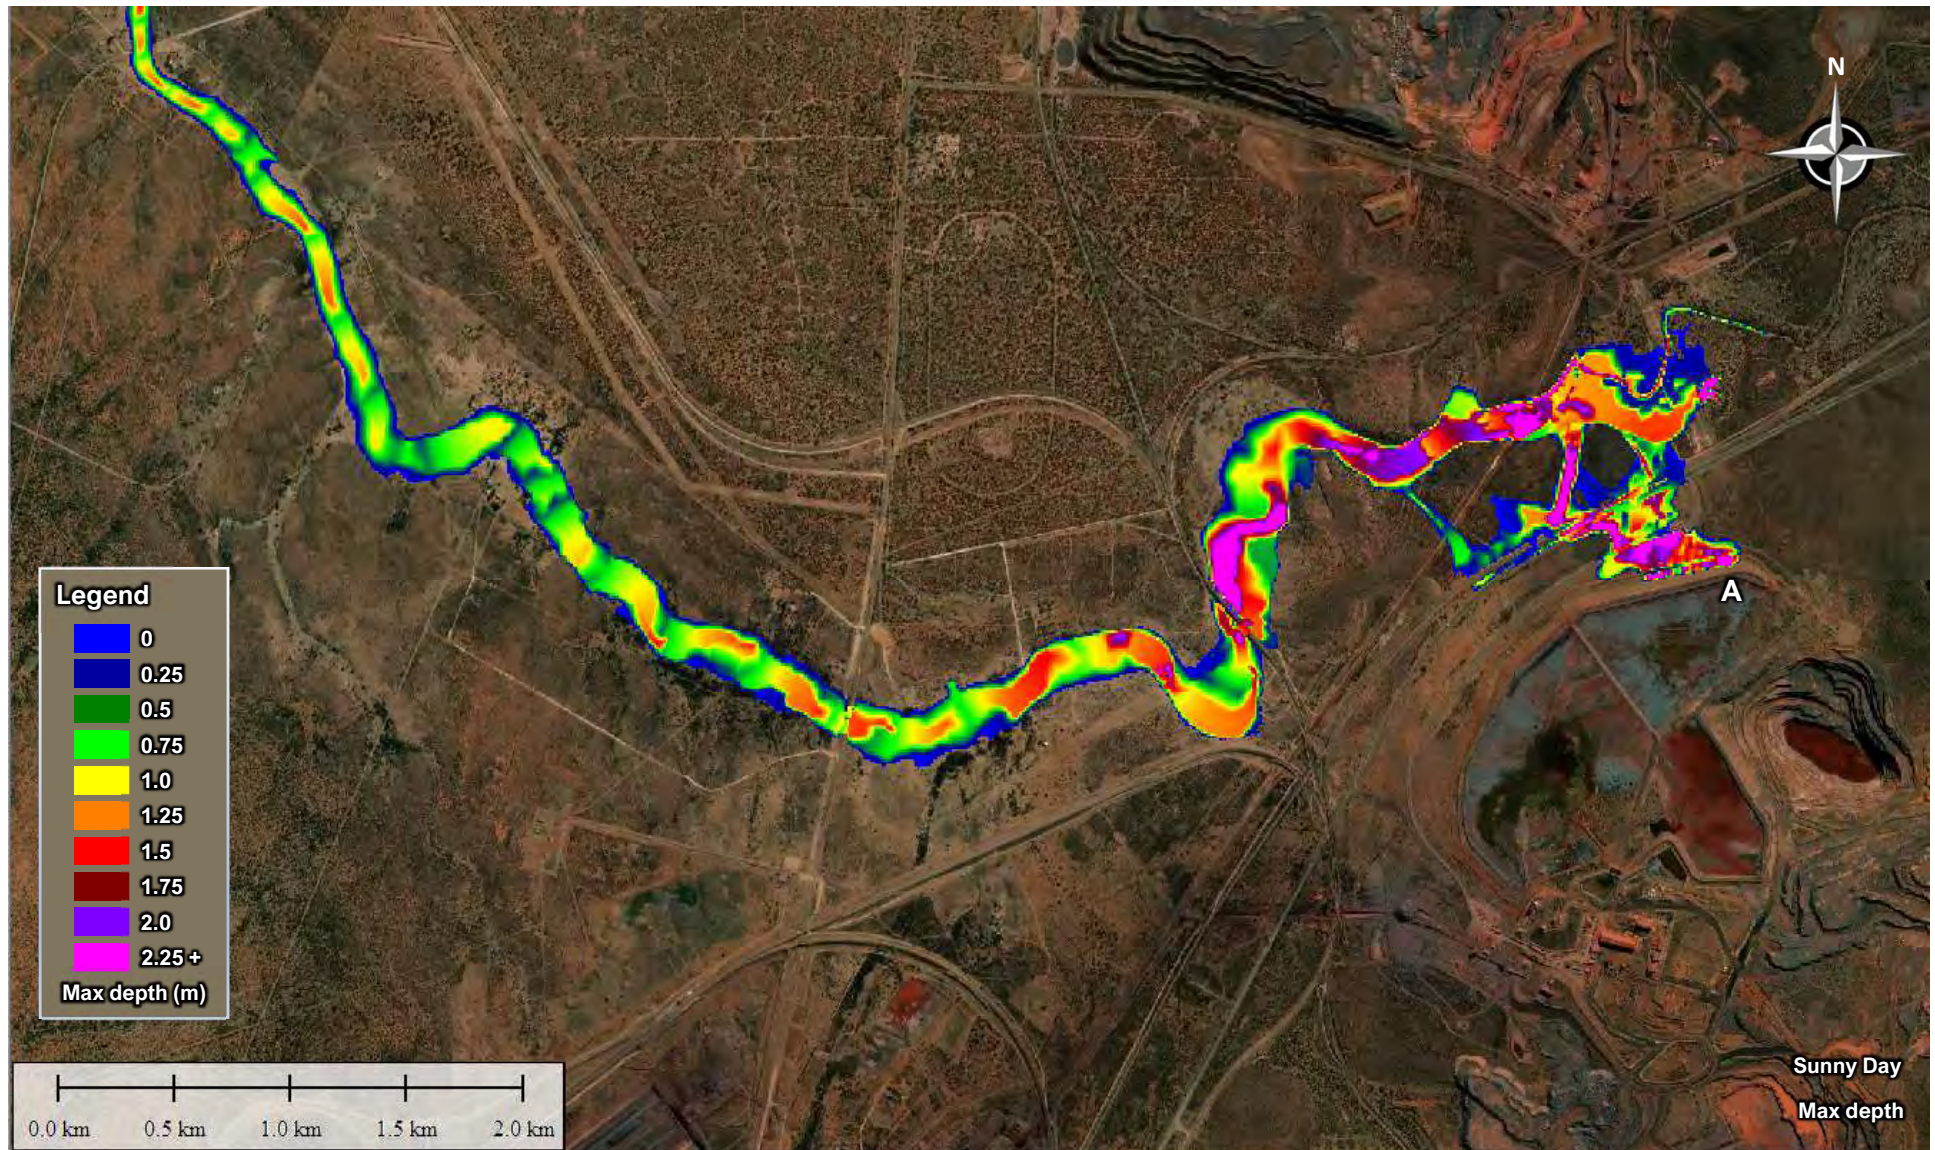
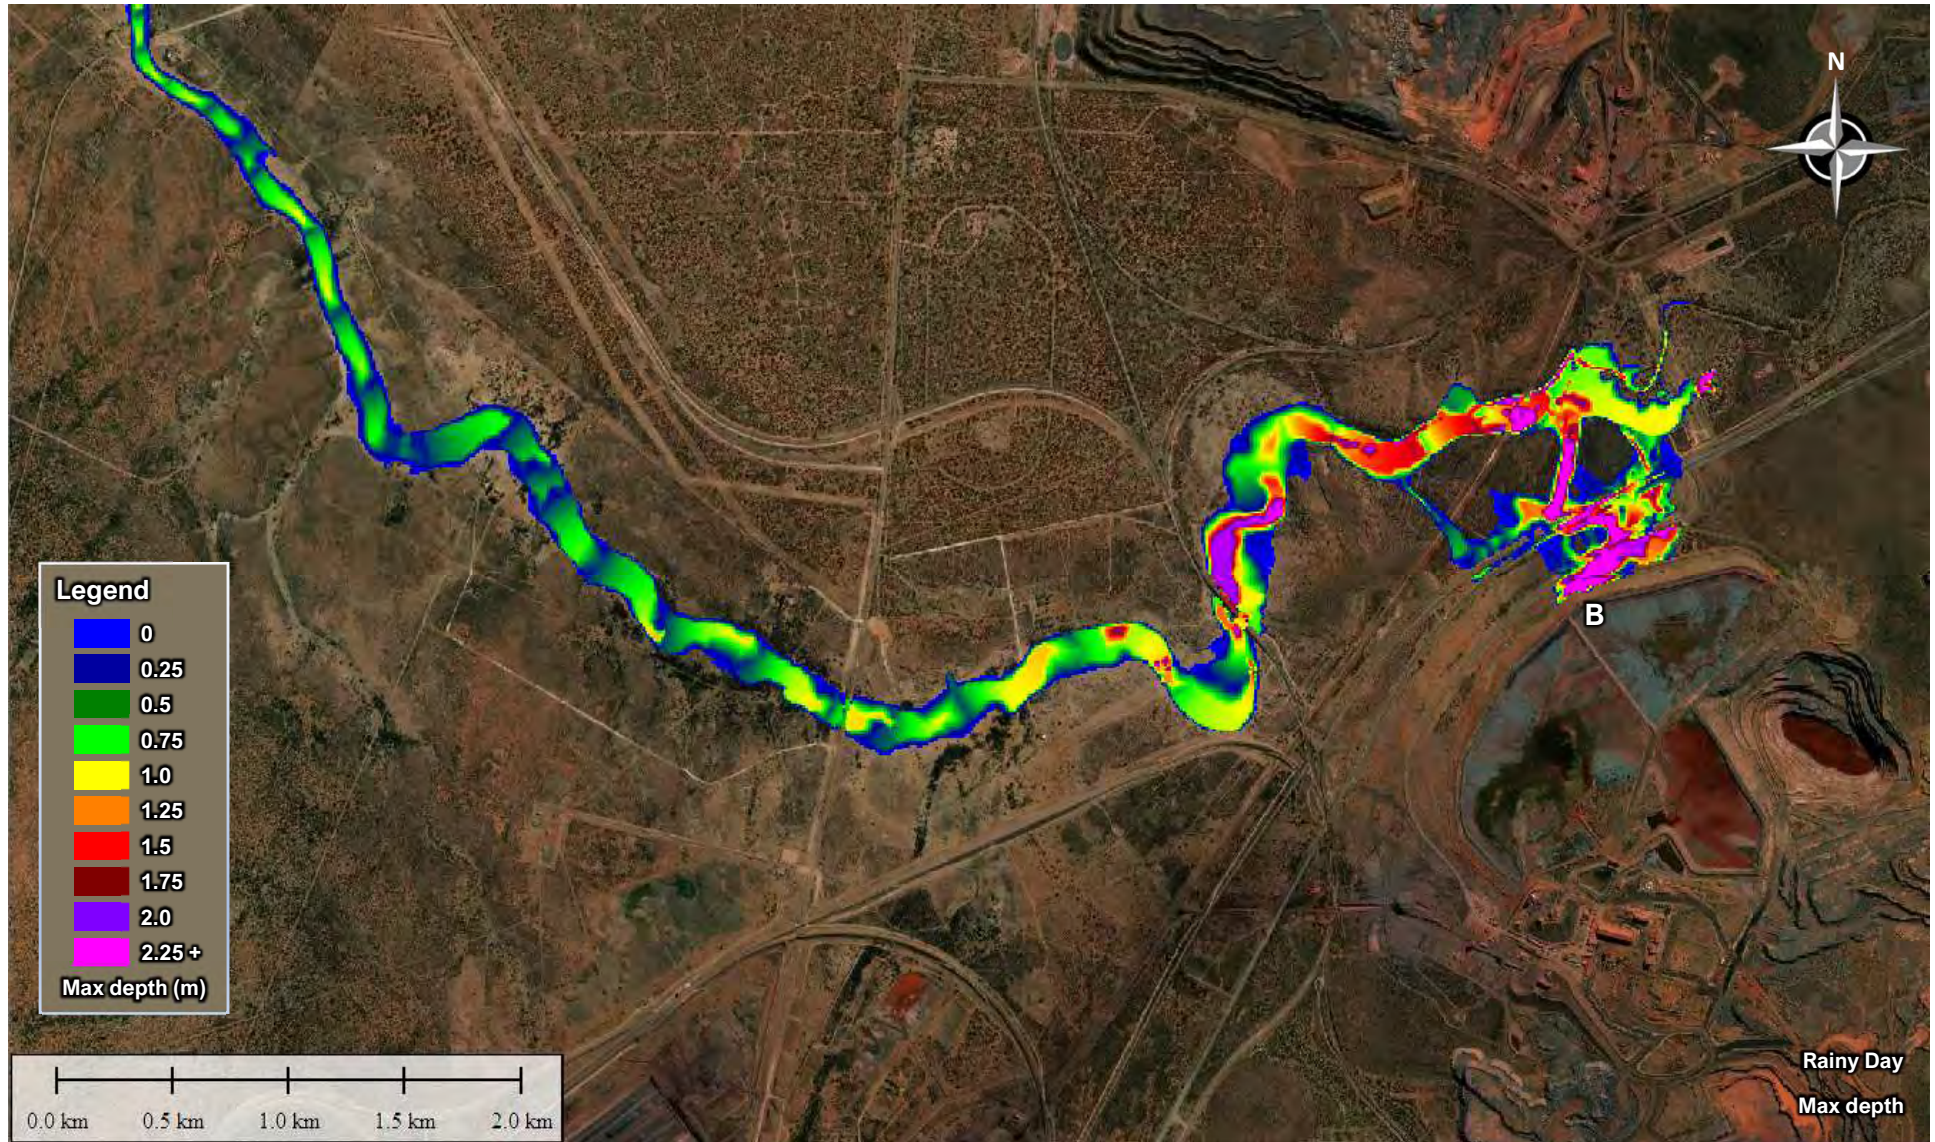
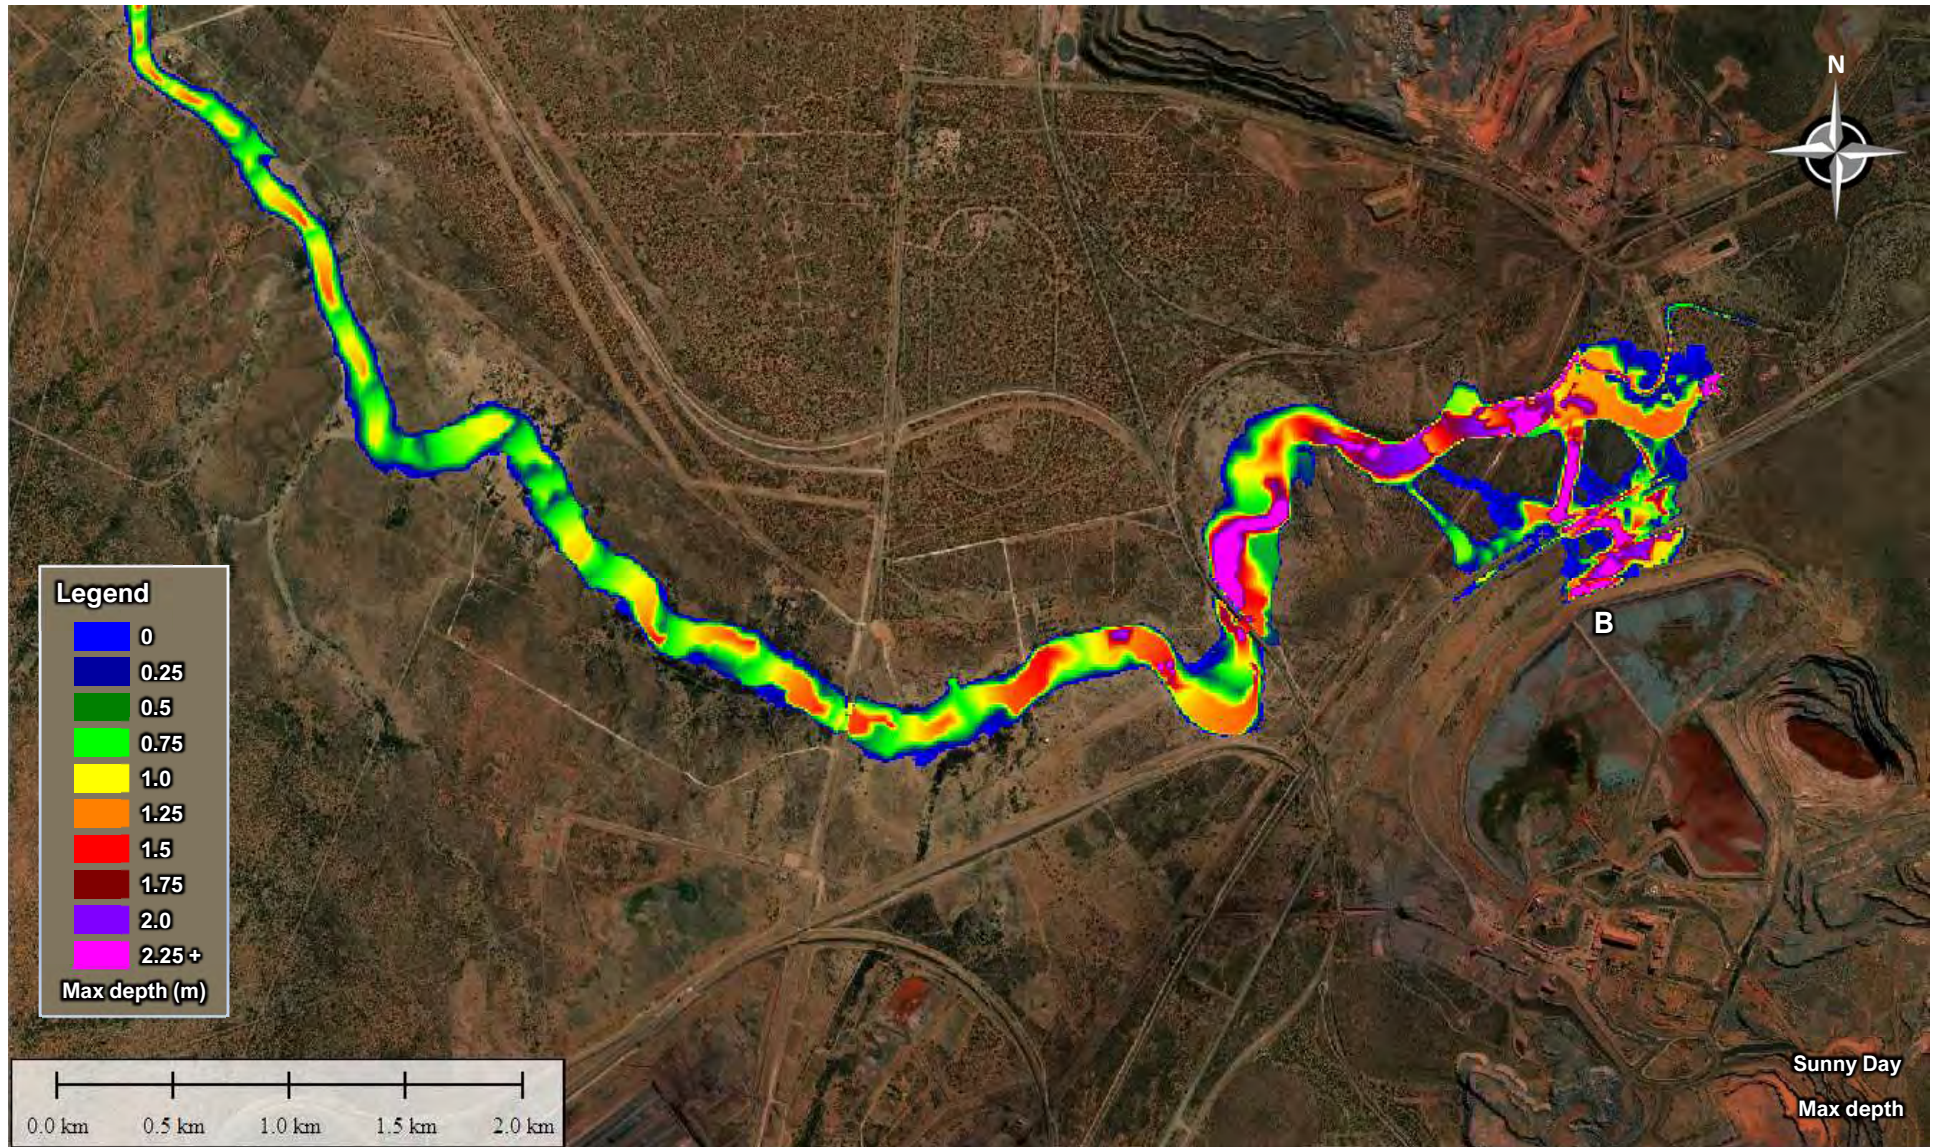
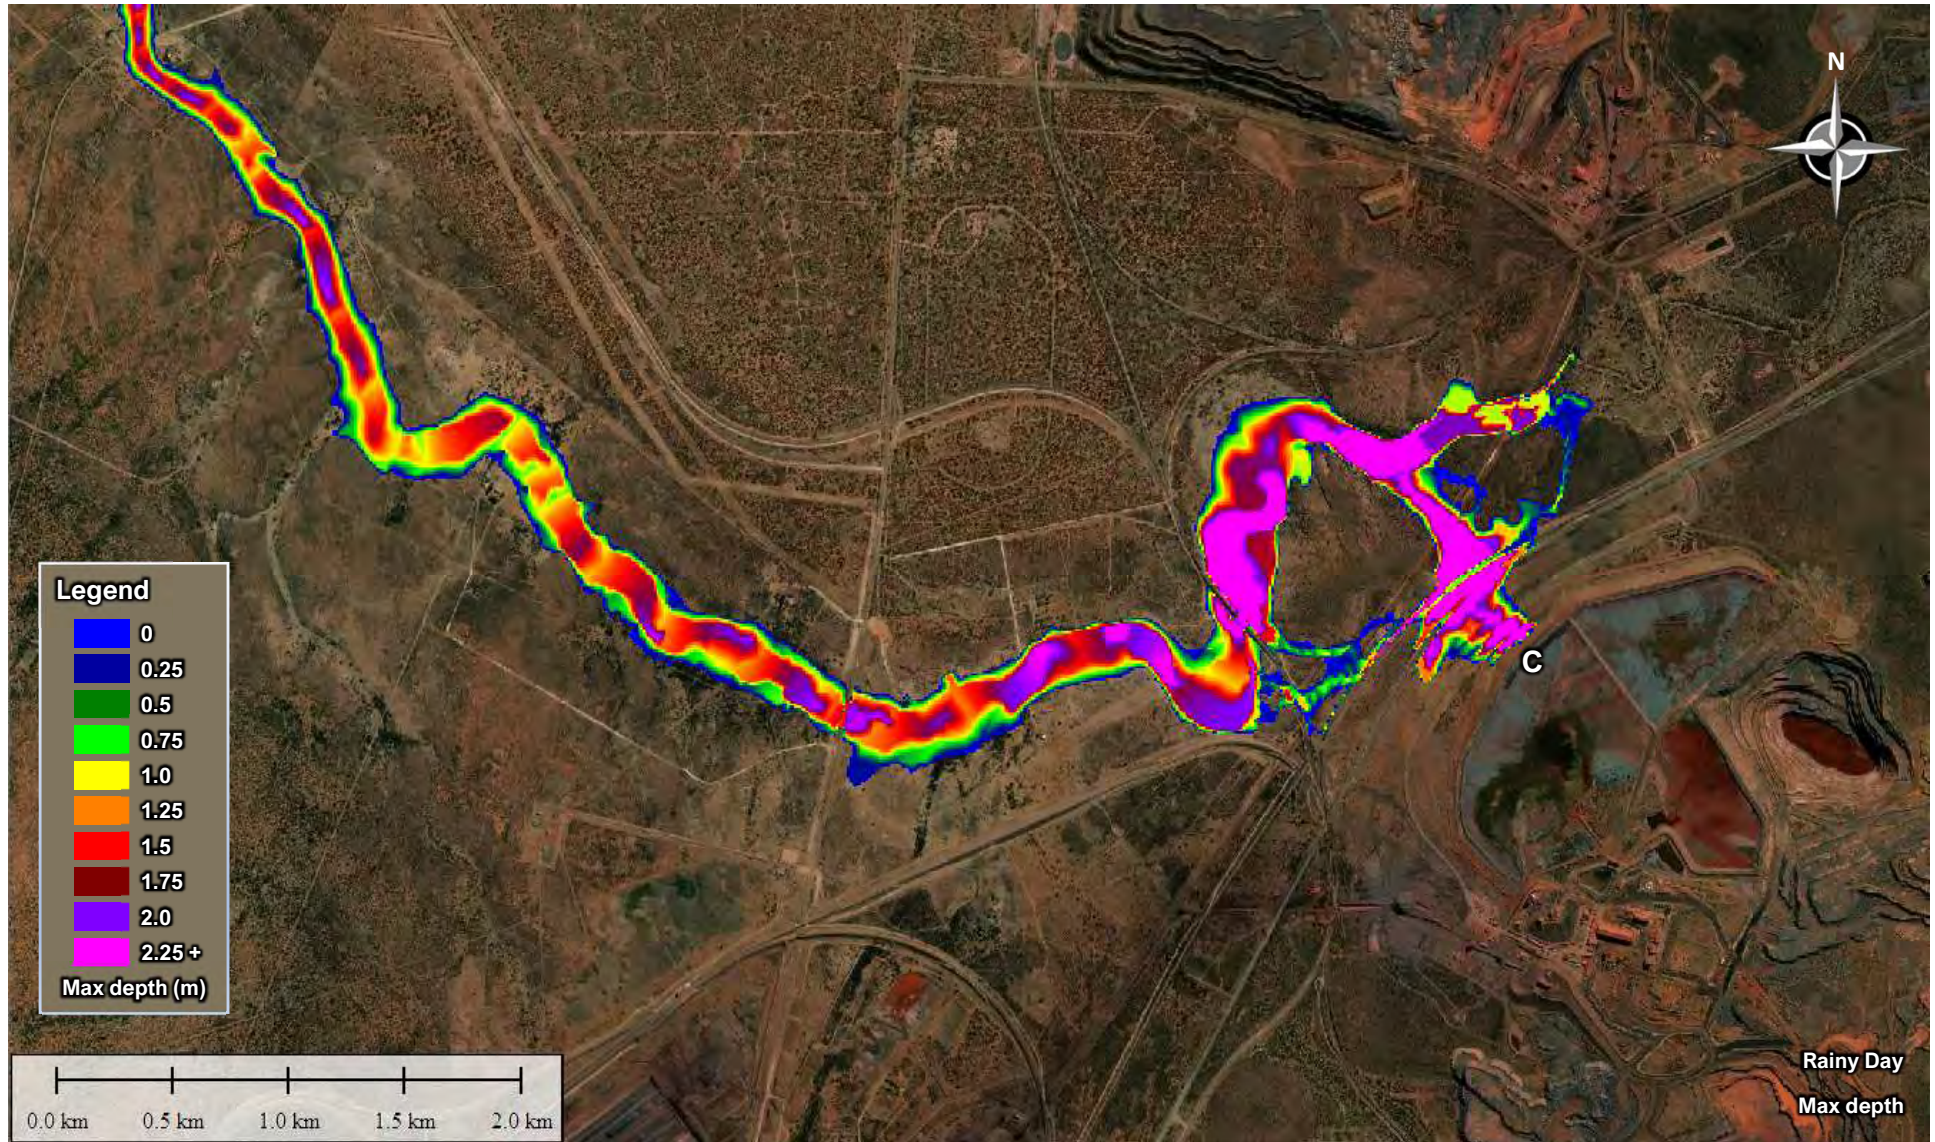
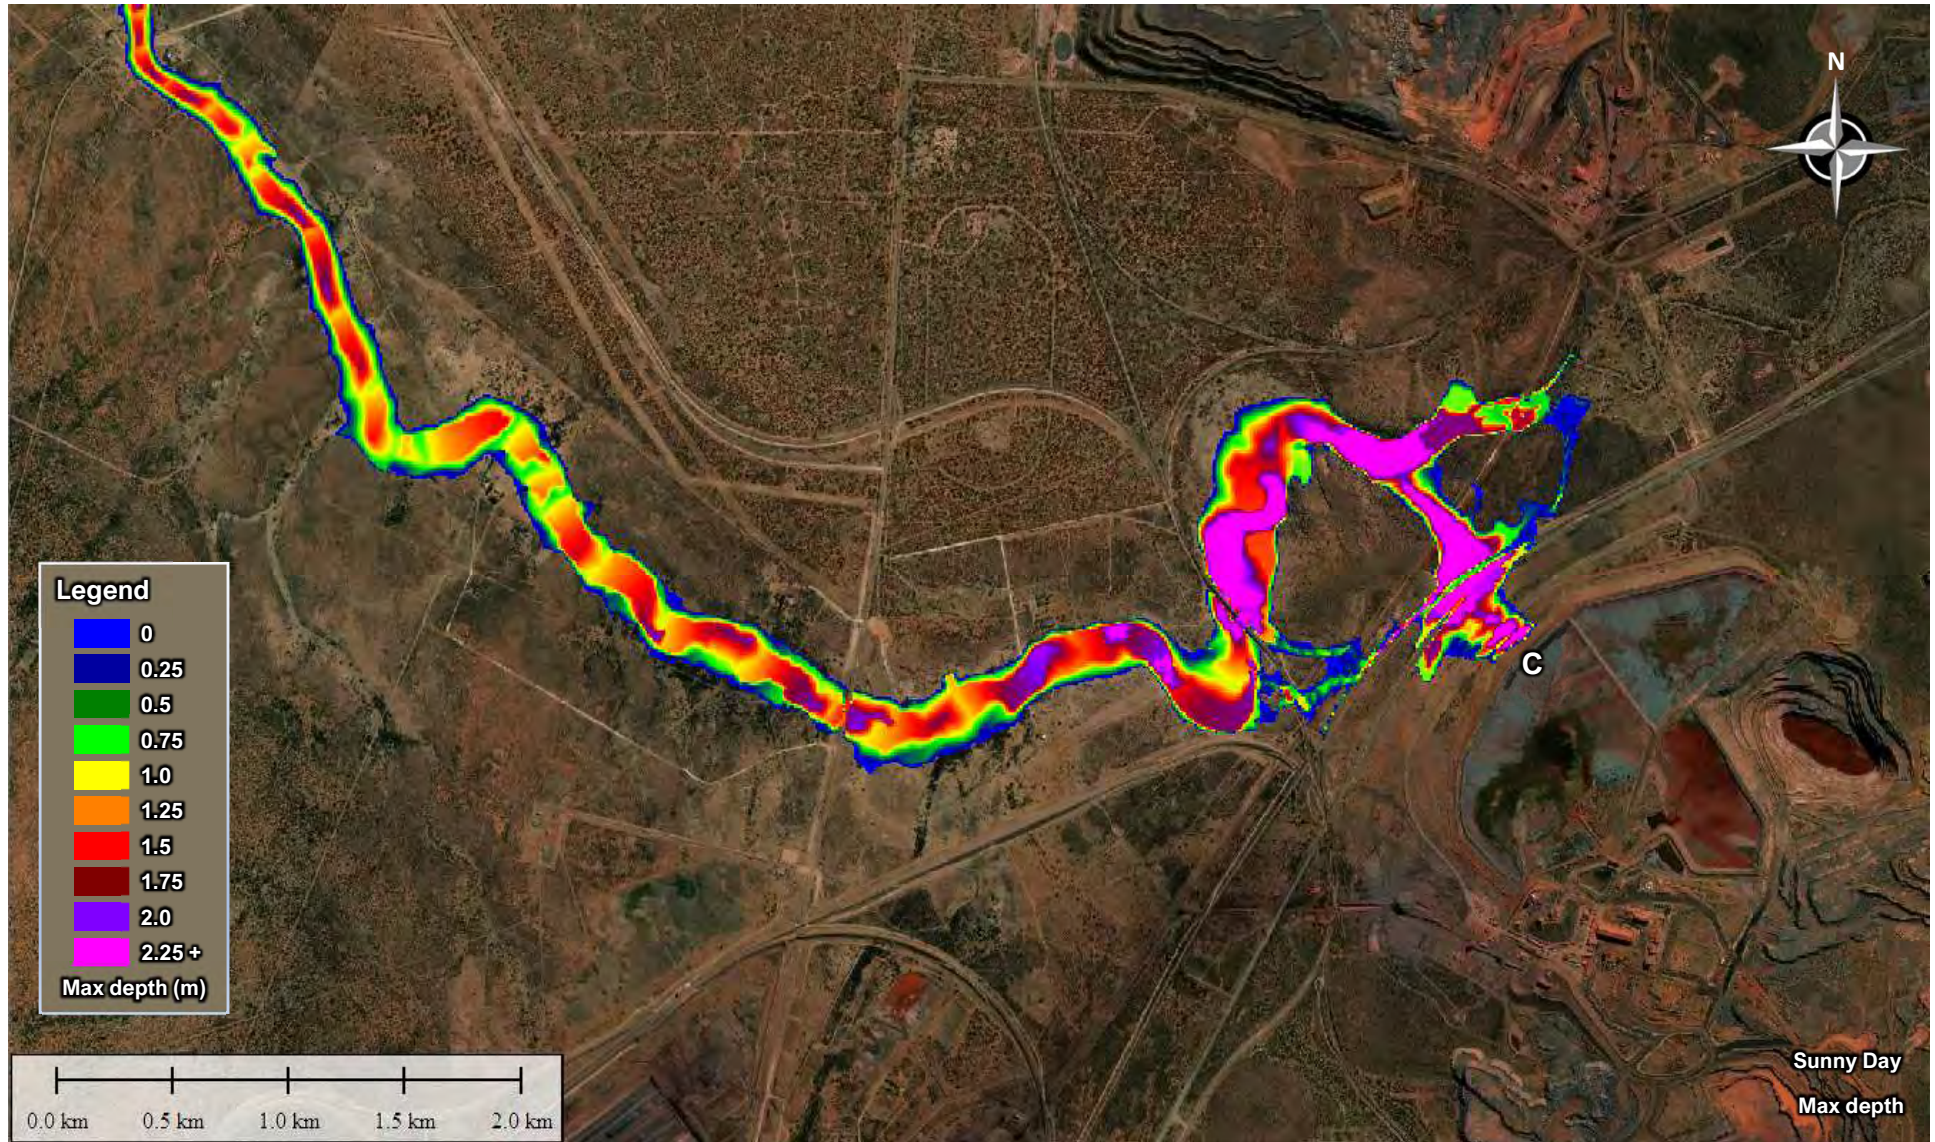
Appendix B: Hazard Potential

The hazard potential is calculated from the product of the flow velocity and flow depth. The hazard potential changes as the flood wave passes a point. The maximum hazard potential is recorded and presented as output. Three hazard classification levels are determined, as detailed in Table 5.
